960 FOUL BAY ROAD—OAK BAY, BC

CONSTRUCTION IMPACT ASSESSMENT & TREE MANAGEMENT PLAN

DATE OF ISSUANCE: December 29th, 2025

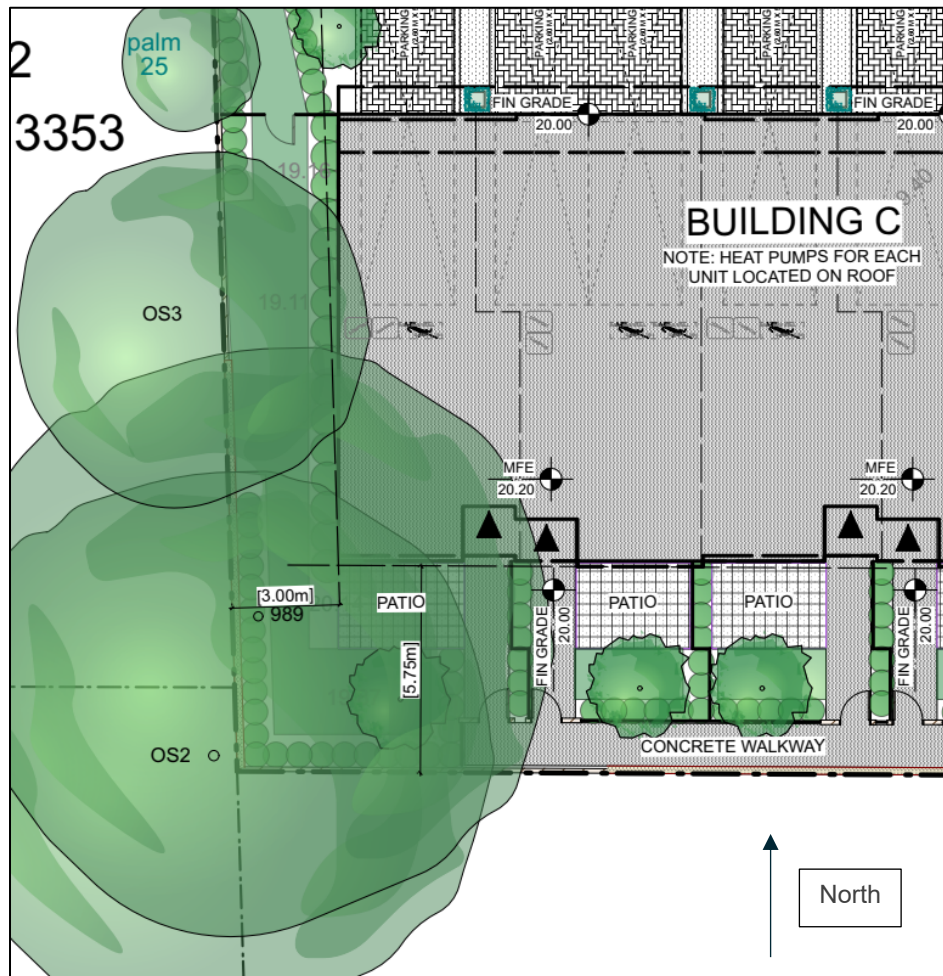
Figure 2: Snapshot from the preliminary building plans July 31st, 2025) showing the foundation wall proposed within the CRZ. **Not to scale.**

- Based on these findings and review of the current building plans (showing “Building C” footprint within 2m of the root collar of #987 and 2.5m from #989, at nearest points) all encountered roots will require pruning if the foundation is constructed as proposed.

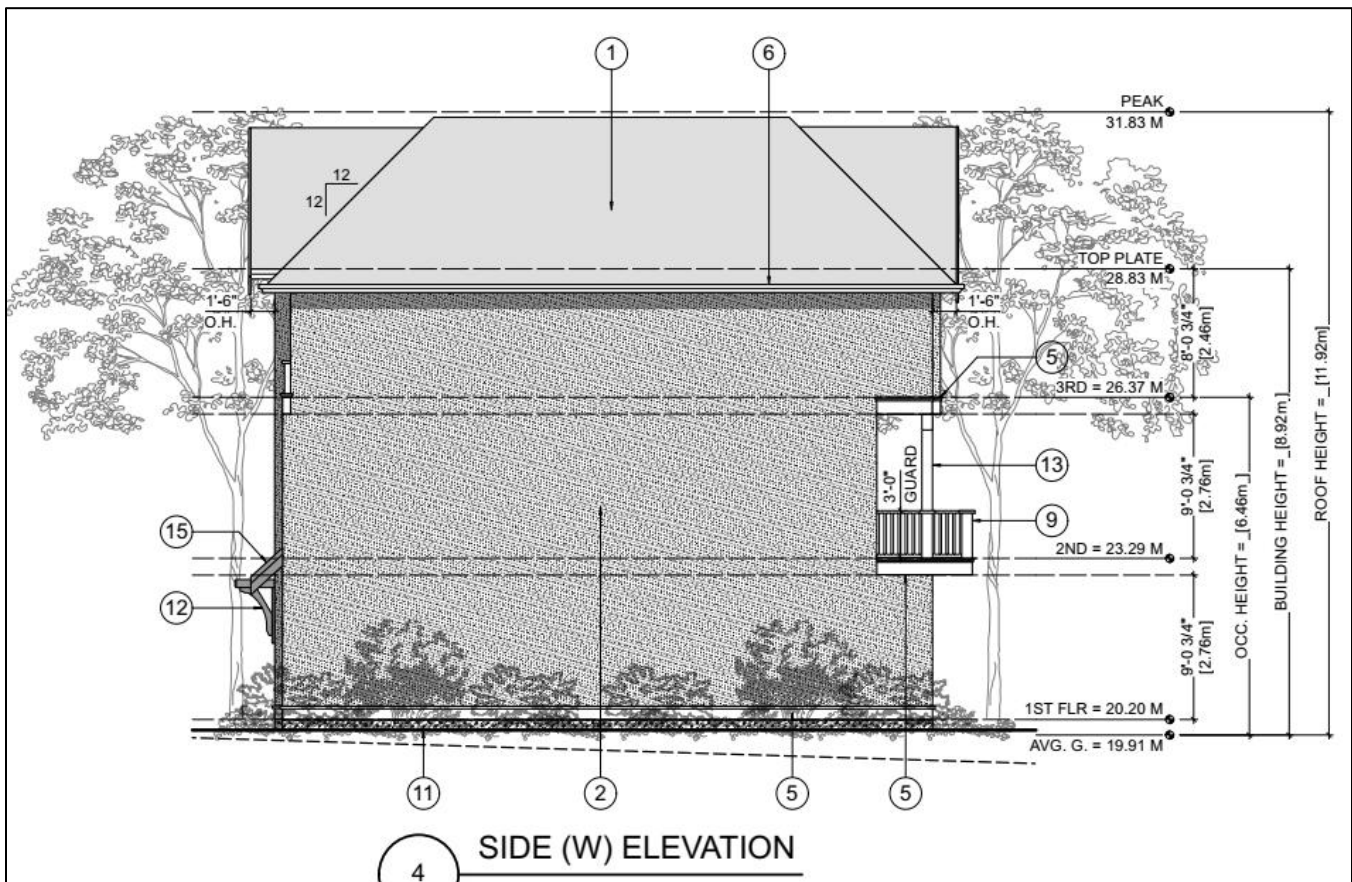
Figure 3: Snapshot from the preliminary building plans July 31st, 2025) showing the proposed “Building C” elevations. **Not to scale.**

- Based on the 11.92m building height specified on the plans and the proximity to the trees, we estimate that the most substantial clearance pruning will be required within the canopies of #989 & 990.
 - #989 will likely require pruning of 2x ~15cm Ø and 2x ~10cm Ø limbs at the branch collars up to ~9m above level (AGL), with larger branches above potentially in need of reduction or removal. **See photograph 18.**
 - #990 will likely require pruning of 2x ~12-15cm Ø and 1x ~10cm Ø limbs at the branch collars up to ~9m AGL, with larger branches above potentially in need of reduction or removal. **See photograph 19.**

- Given the relatively strong wound compartmentalization exhibited by the species, it is our opinion that the proposed clearance pruning is unlikely to result in significant impacts to the long-term health or structural condition the tree, provided large limbs are maintained above ~9m AGL. Based on the proposed 1:1 slope of the roof line, retained limbs above 9m AGL should maintain at least 1m clearance from finished eaves and roofing. The project arborist should be contacted to meet with the pruning contractor prior to commencement of work. All pruning shall be completed by an ISA Certified Arborist.

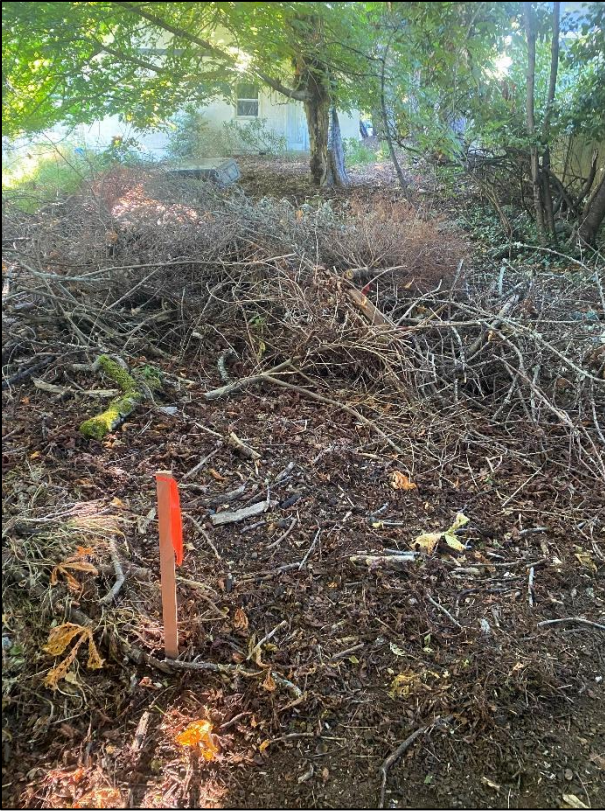
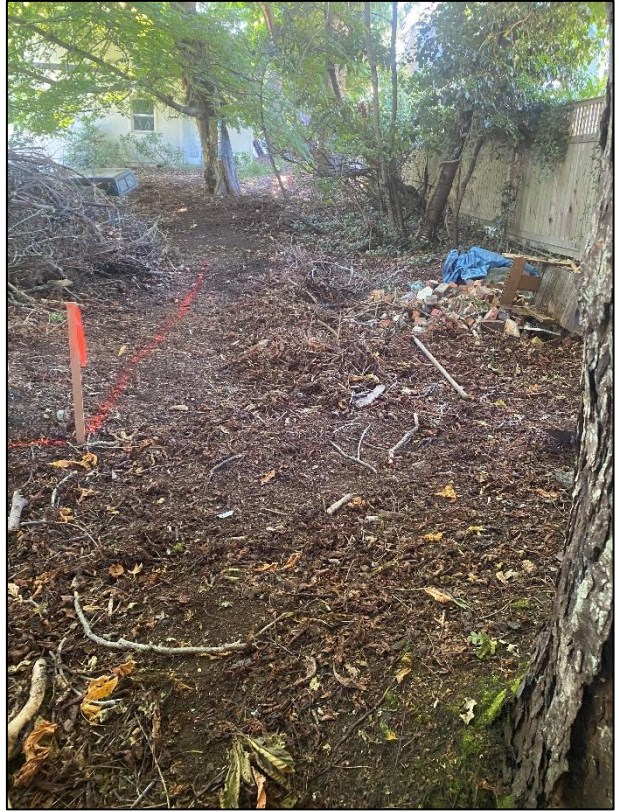
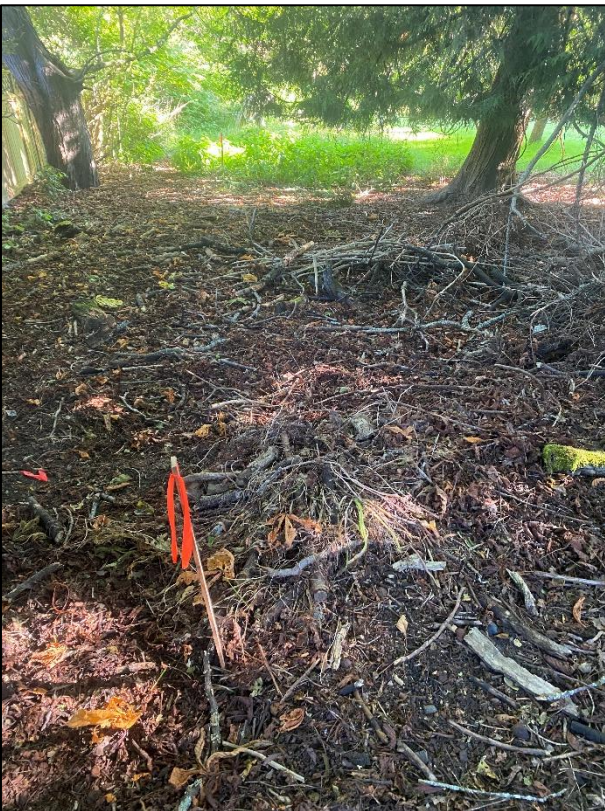
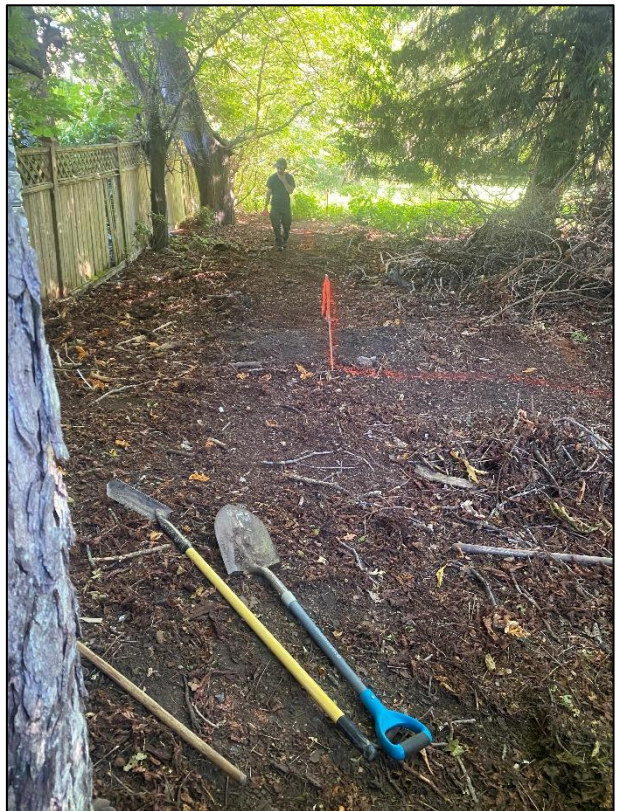
Photographs 2-5: Prior to breaking ground, the proposed corners of "Building C" were identified by a survey team using wooden stakes with orange marking ribbon. We then removed existing debris near the subject trees and delineated the lines of our exploratory excavations with orange marking paint.

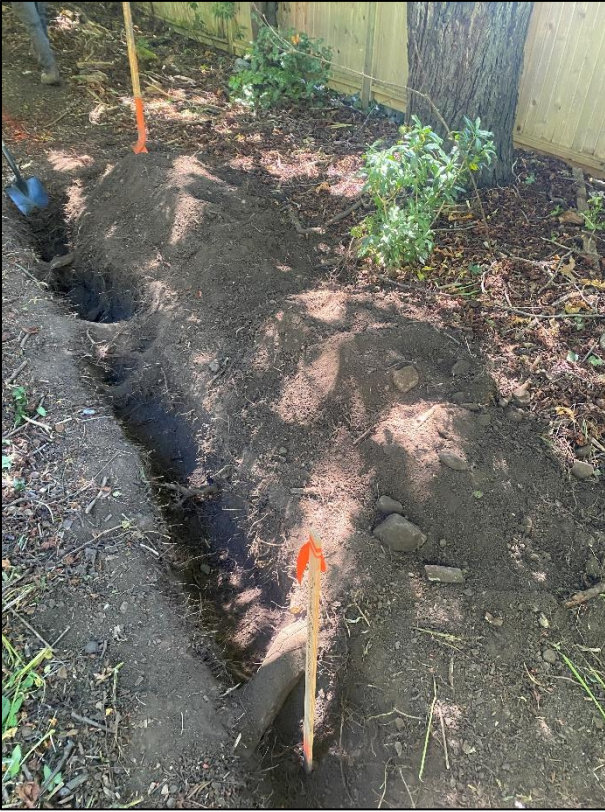
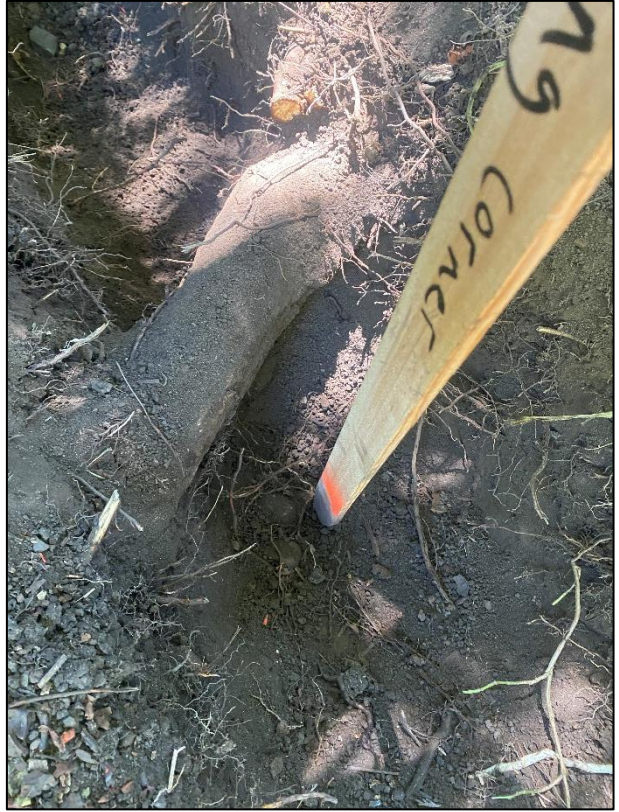
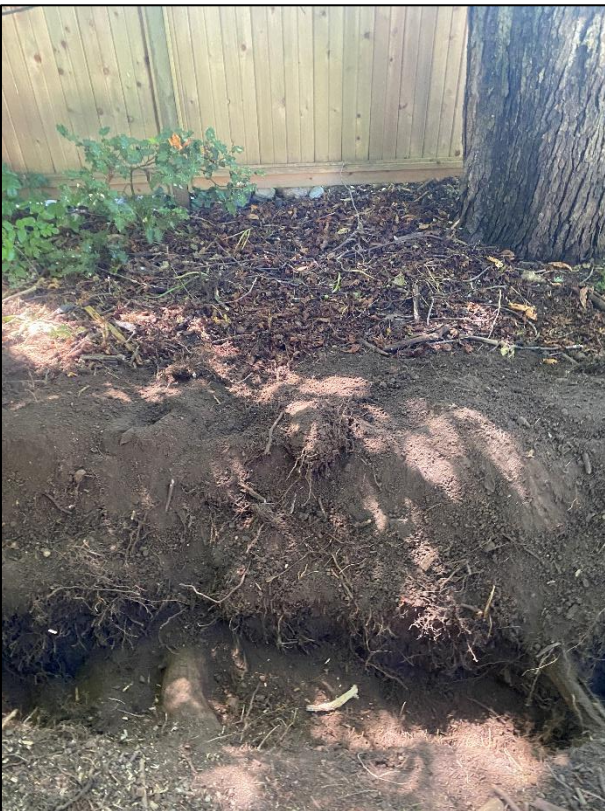
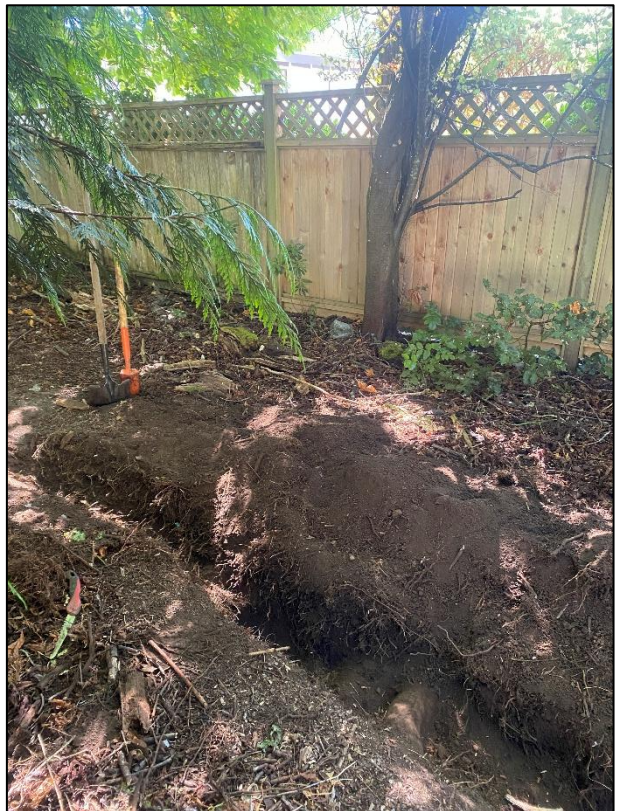
- We encountered 2x roots likely originating from #987 that would be considered structural (>10 cm diameter).
- We also encountered 2x clusters of medium-sized roots that may be providing structural strength to #989 (and possibly #990).
- The root systems were observed to be quite shallow, with most roots located in the upper ~30-45cm of undisturbed soil.
- The new foundation is proposed slab-on-grade—however, excavation to load-bearing soil (~>60cm depth) will likely be required, and we anticipate over-excavation will be necessary if standard footings are used for construction:

Photographs 6-9: Exploratory excavation within the CRZ of #987 encountered 1x >10cm Ø root at ~30cm south of the proposed "Building C" corner (**above**), 1x >10cm Ø root at ~4m south of the corner (**below**), a cluster of roots <5cm Ø and 1x 4cm Ø root (**upper and lower left**) at ~2-3m from the corner.

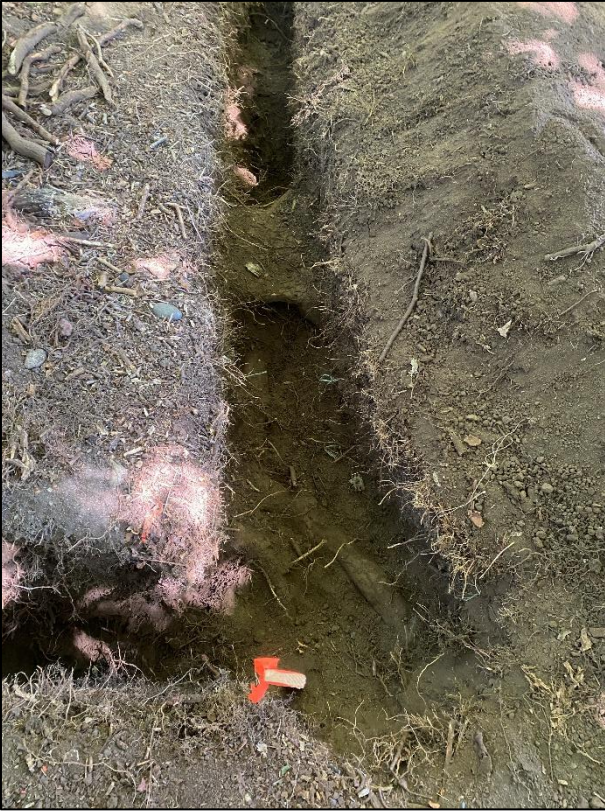
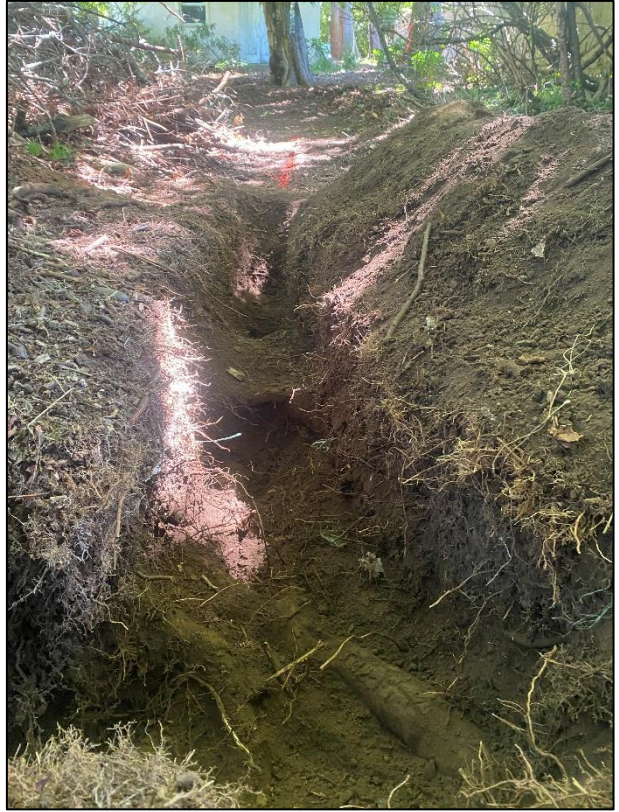
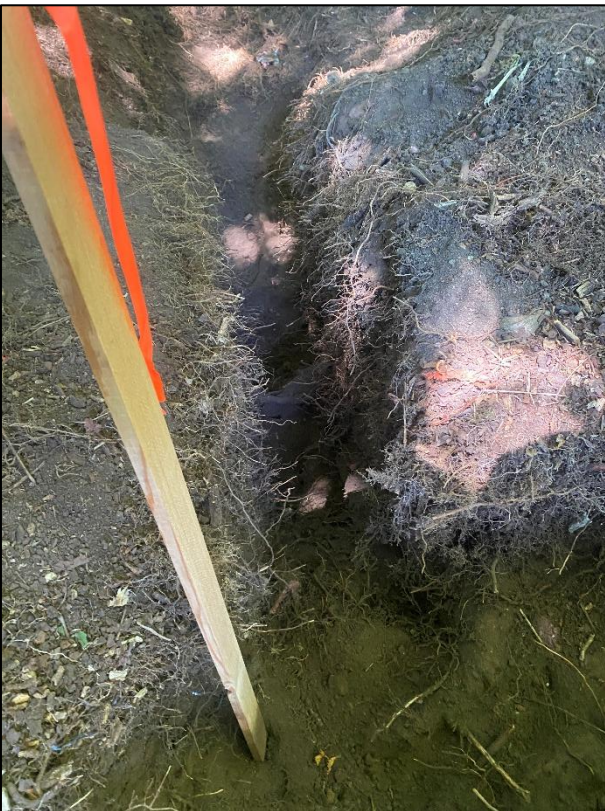
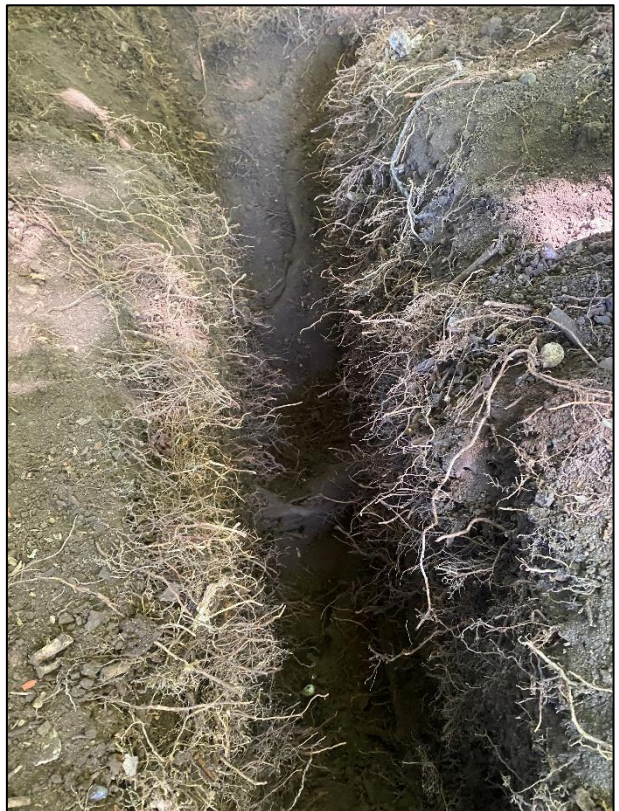
Photographs 10-13: Exploratory excavation within the CRZs of #989 & 990 encountered a cluster of medium-sized roots (~5-9cm Ø) at ~0.5m north of the proposed "Building C" corner (**above**) and a similar cluster at ~1m east of the corner (**below**). 1x ~8cm Ø and 1x ~6cm Ø were also encountered at the corner itself (**above**). An additional 1x ~6cm Ø root was encountered at ~1.5m north of the corner (**below**).

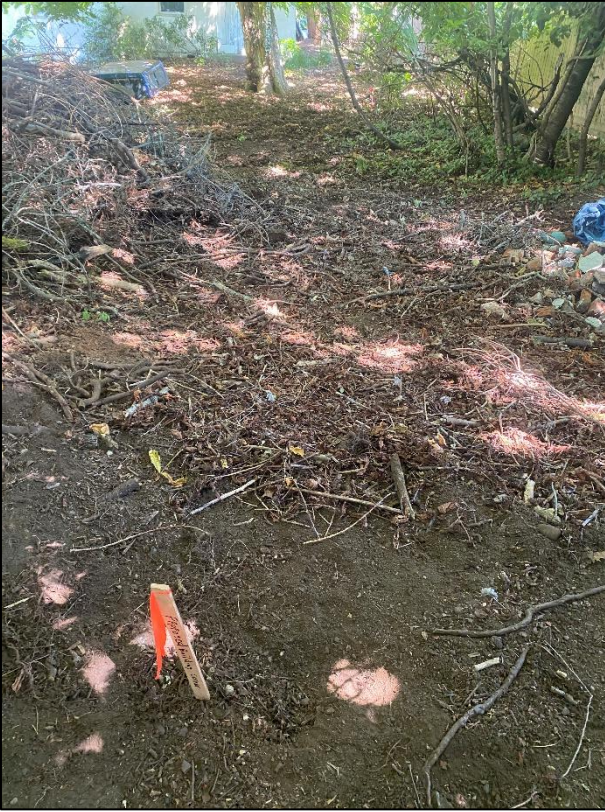
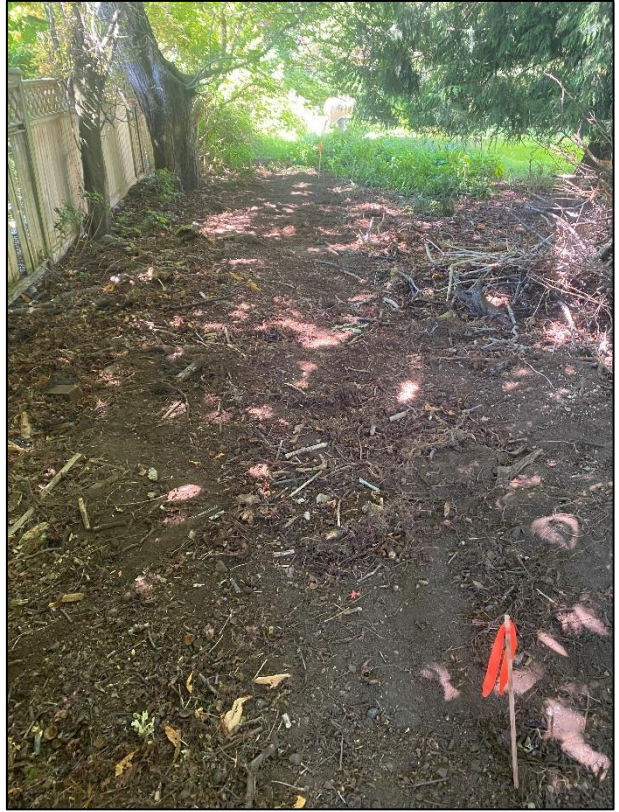
Photographs 14 & 15 (above): The hand-dug trenches were backfilled with on-site soil once exploratory excavations were complete.
Photographs 16 & 17 (below): #987 with decayed wound in lower trunk (left); #989 with inclusion and potential decay near the union (right).

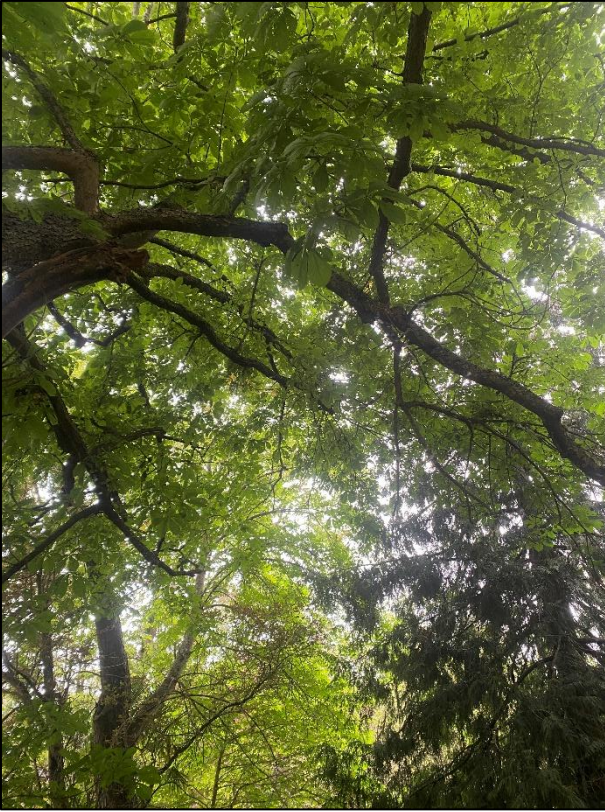
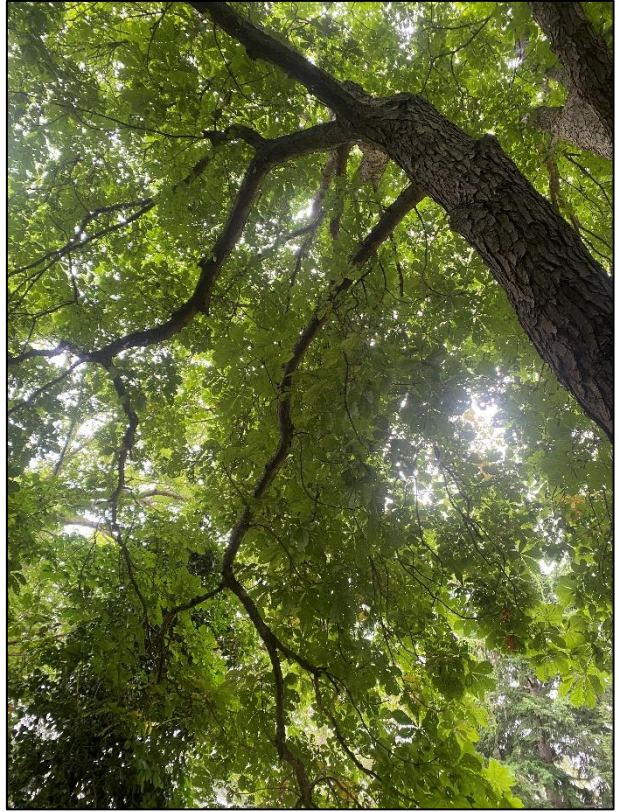
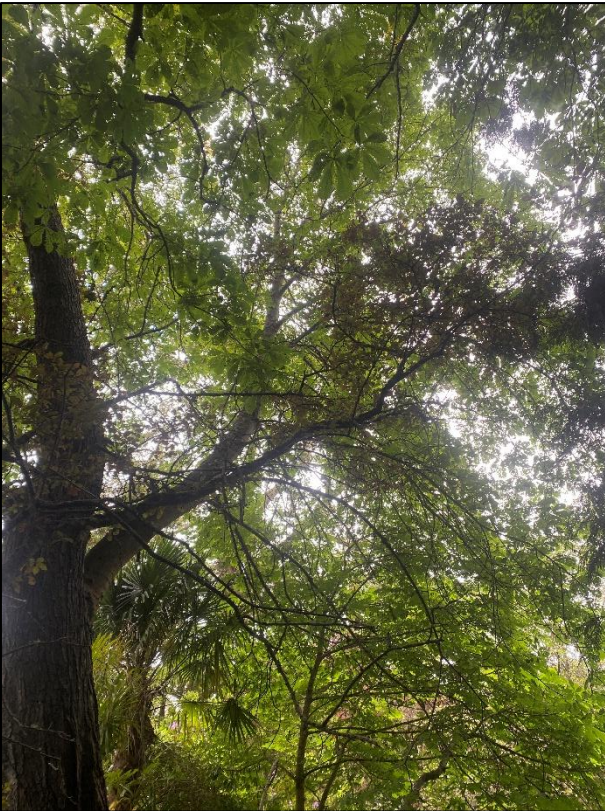
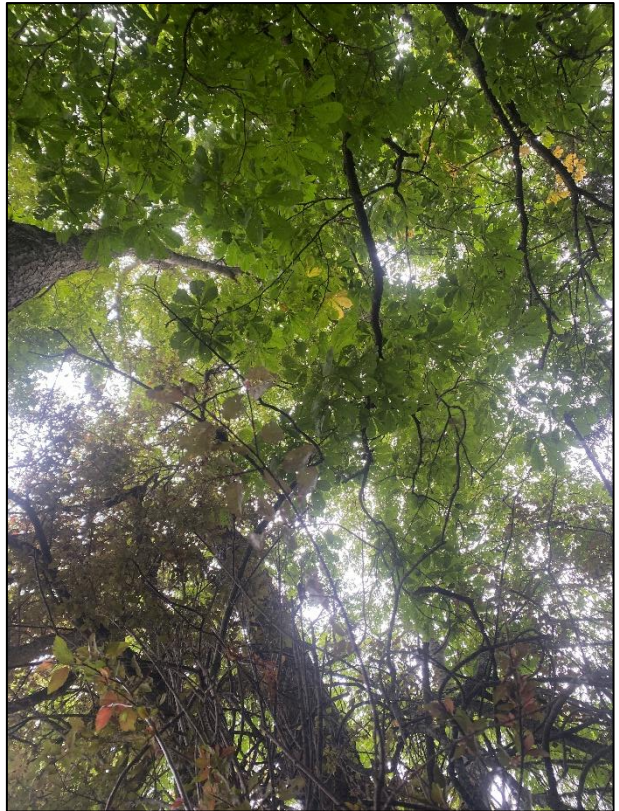
Photographs 18-21: Canopies of #987 (lower left), 989 (upper left), 990 (upper right), and OS3 (lower right) that require clearance pruning for the construction of the proposed "Building C."
