960 FOUL BAY ROAD—OAK BAY, BC

CONSTRUCTION IMPACT ASSESSMENT & TREE MANAGEMENT PLAN

DATE OF ISSUANCE: January 2, 2025

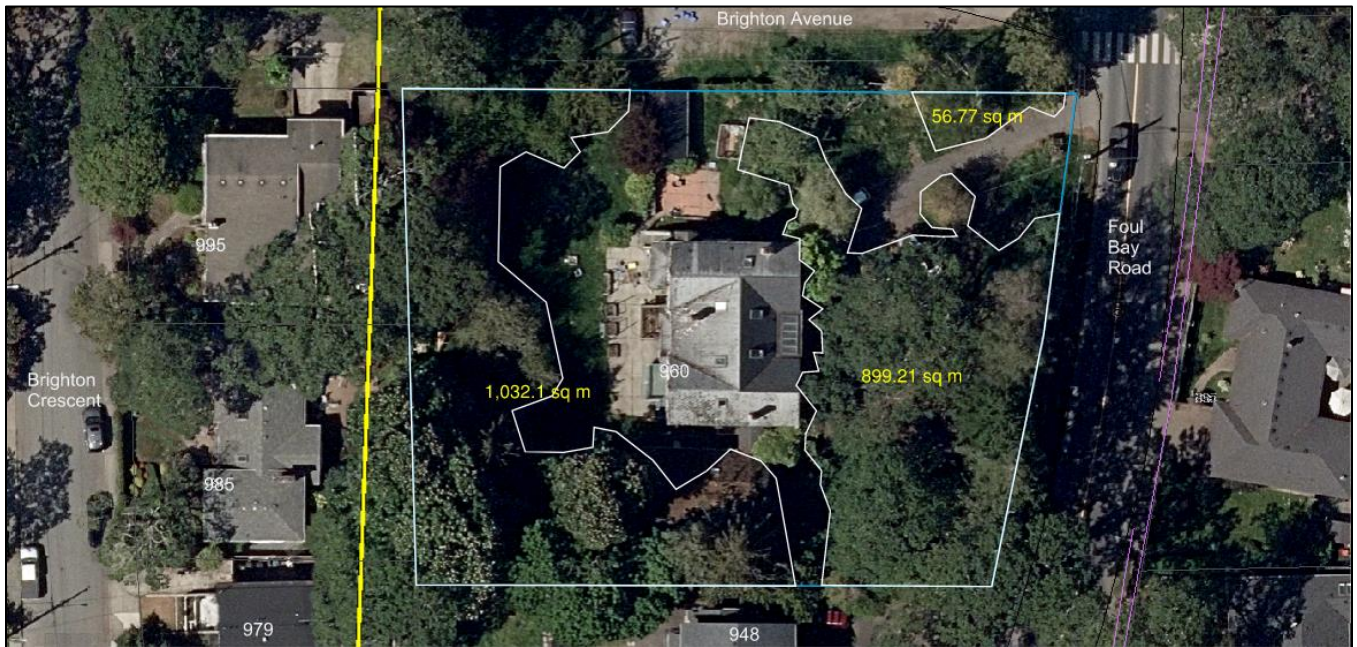
Figure 2—existing canopy coverage: 1,988.08.m² or 59.8% of total lot area (3322m²).

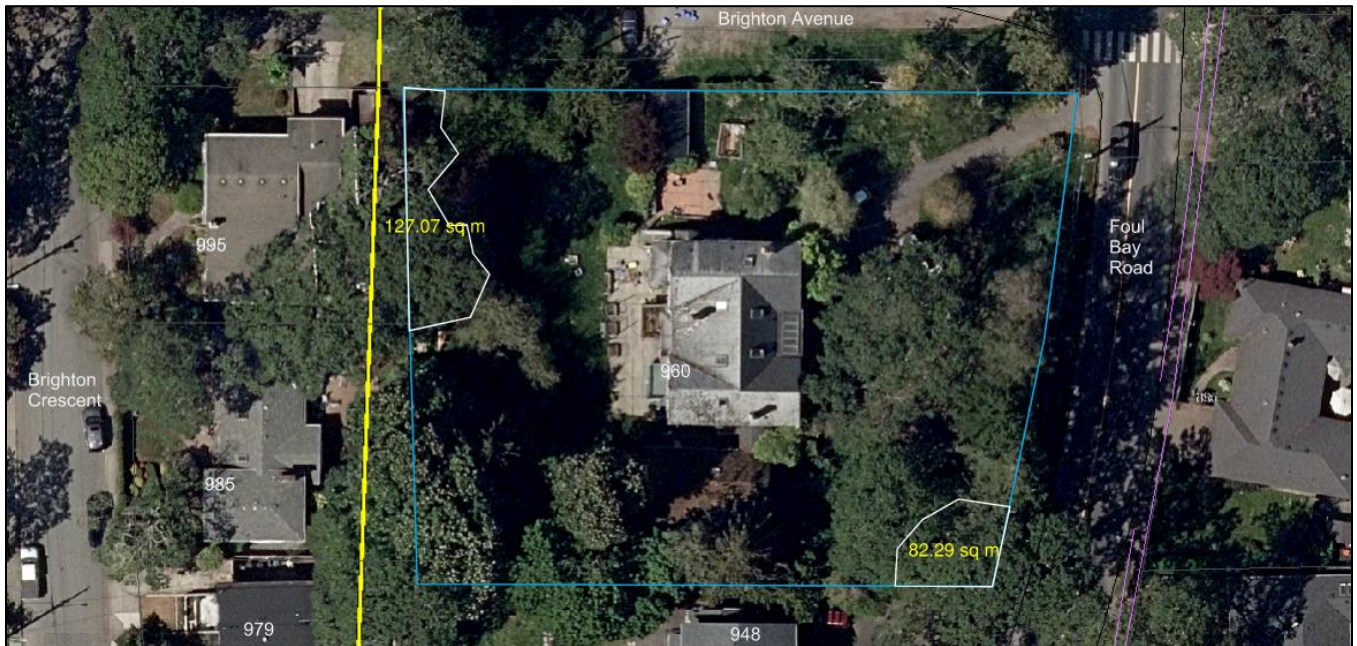
Figure 3—post-construction canopy coverage: 209.36m² or 6.3% of total lot area (3322m²).

Figure 4—canopy coverage calculations: 35% or 1162.7m² is required for RS-4 zoning. An additional 953.34m² must be incorporated into the landscape—this can be accomplished by planting seven (7) large canopy (at maturity) tree (credit 125m²) and two (2) medium canopy tree (credit 50m²), or equivalent combination of large, medium, and small trees. Based on Section 10.8 of Tree Protection Bylaw No. 4742, "...where a tree for which a replacement tree is required is a Garry Oak, the replacement tree must be of the same species." Four (4) replacement Garry Oaks must be incorporated into the landscape plan.

The building plans also show twenty-eight (28) small trees, two (2) medium trees, and five (5) large trees proposed for planting on-site, which should satisfy the canopy coverage requirements outlined in **Appendix B**, provided these meet bylaw criteria for replacement trees. However, additional compensation will be required for the outstanding nineteen (19) replacement trees. Any replacement tree shortfall shall be compensated cash-in-lieu.
