960 FOUL BAY ROAD—OAK BAY, BC
CONSTRUCTION IMPACT ASSESSMENT &
TREE MANAGEMENT PLAN

PREPARED FOR: 960 Foul Bay Holdings c/o Jennifer Travelbea
754 Humboldt Street
Victoria, BC
V8W 4A1

PREPARED BY: Talmack Urban Forestry Consultants Ltd.
Robert McRae – Consulting Arborist
ISA Certified # PN-7125A
Tree Risk Assessment Qualified
Tree Appraisal Qualified

DATE OF ISSUANCE: December 29th, 2025

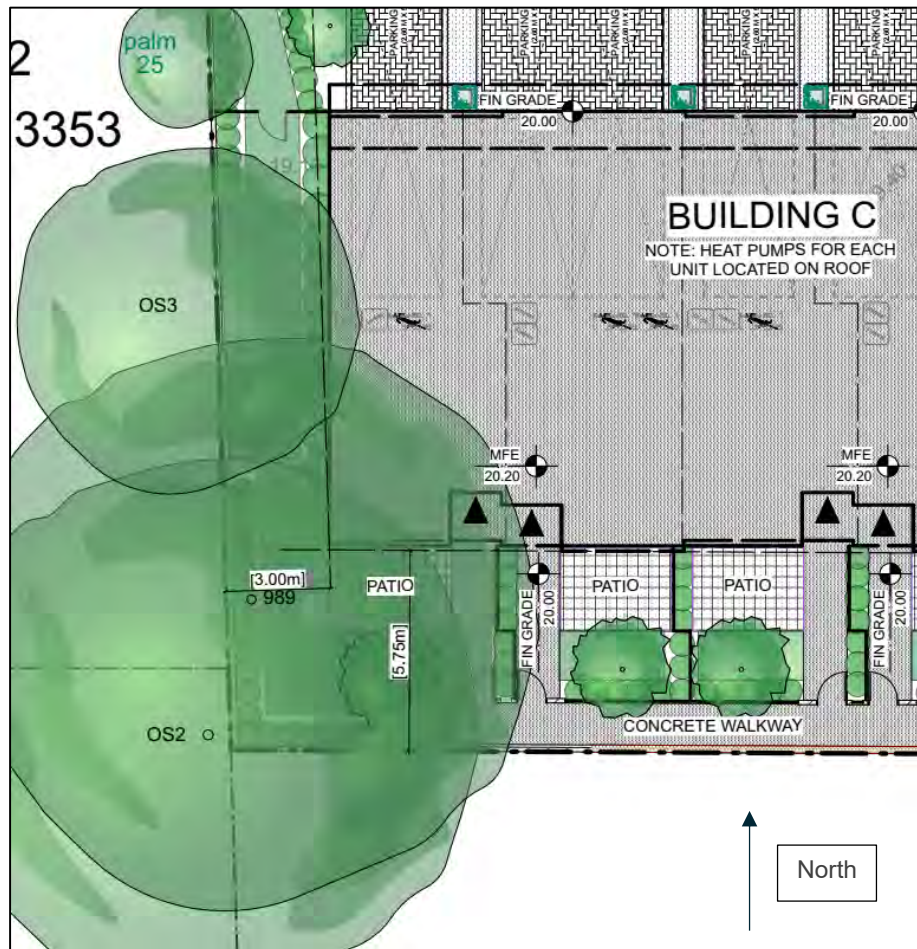
Figure 2: Snapshot from the preliminary building plans July 31st, 2025) showing the foundation wall proposed within the CRZ. **Not to scale.**

- Based on these findings and review of the current building plans (showing “Building C” footprint within 2m of the root collar of #987 and 2.5m from #989, at nearest points) all encountered roots will require pruning if the foundation is constructed as proposed.

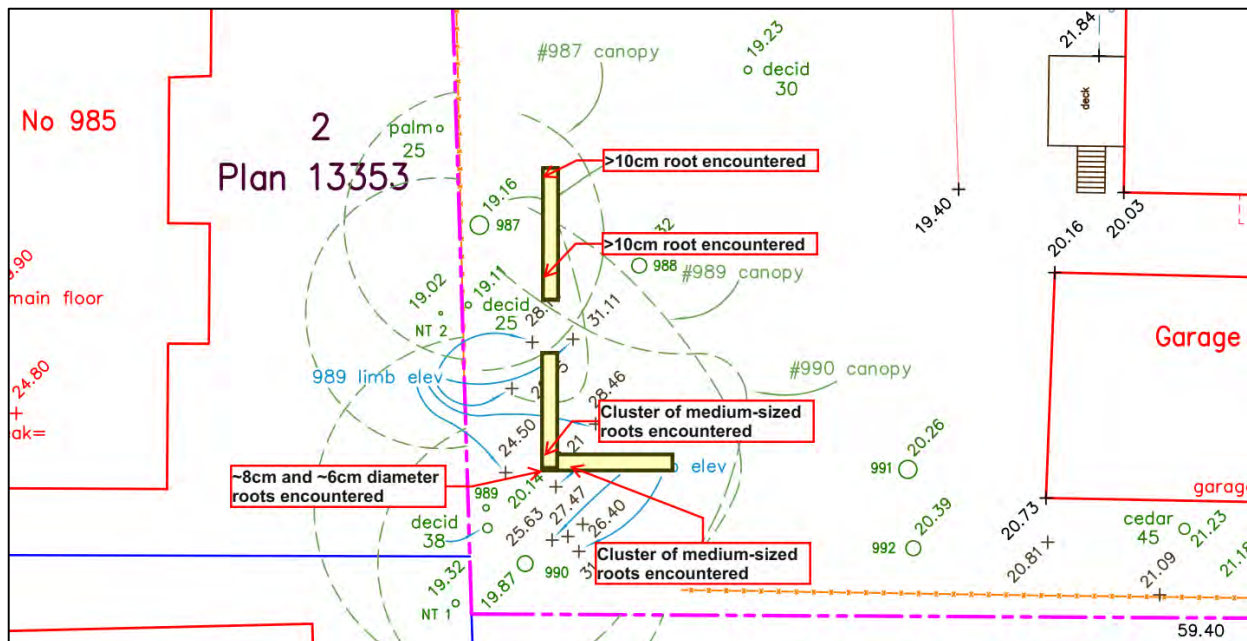
Figure 4: Snapshot from the site survey (dated June 18th, 2025). Approximate exploratory excavation area indicated by yellow rectangles. Approximate locations of significant roots encountered identified with red callout.

- Any roots critical to the trees' survival must be retained and any non-critical roots in direct conflict with the excavation must be pruned to sound tissue to encourage new root growth. We anticipate the 8cm Ø and 6cm Ø diameter roots encountered at the southwest corner of proposed "Building C" will require pruning, since this point may be critical to the structural integrity of the foundation. For helical pilings or pier footings—we recommend utilizing hydro excavation, air spade, or hand tools to expose non-critical roots in conflict with the proposed excavation and prune them back to sound tissue to give them the best opportunity for compartmentalization and new growth.

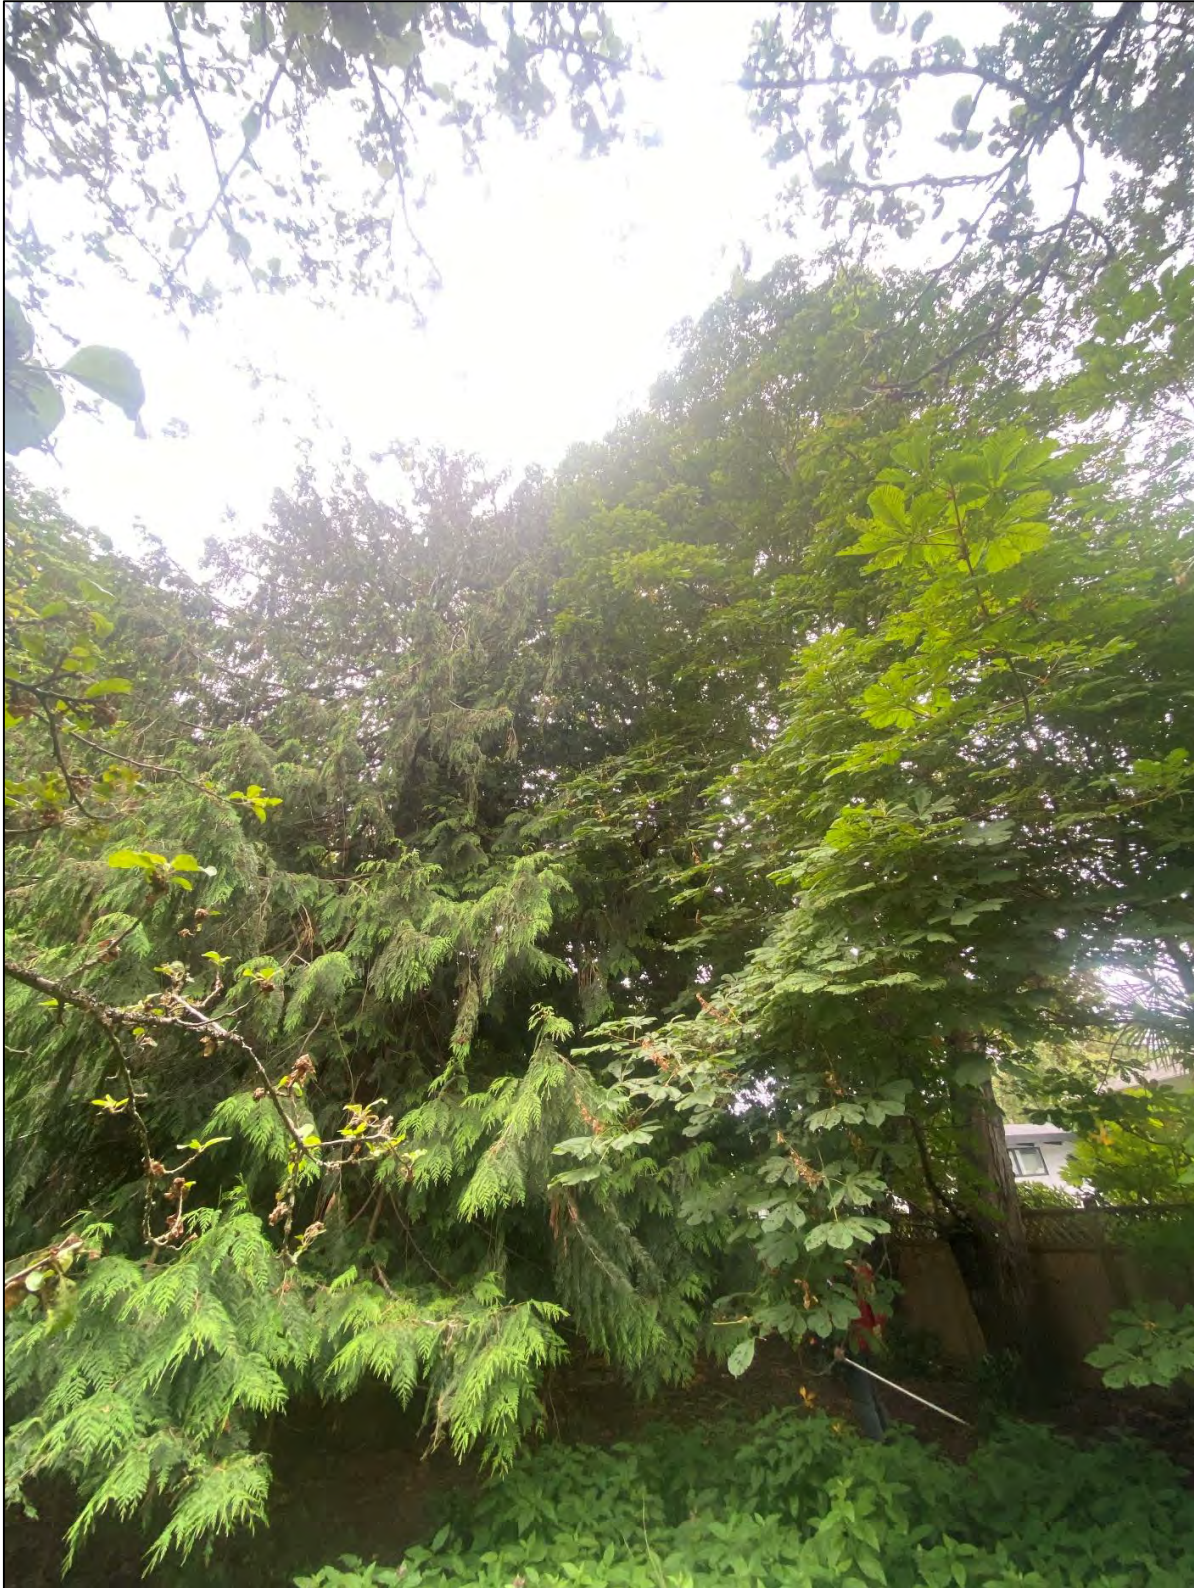
Photograph 1: *The trees were in fair-good health on the date of our site visit.*

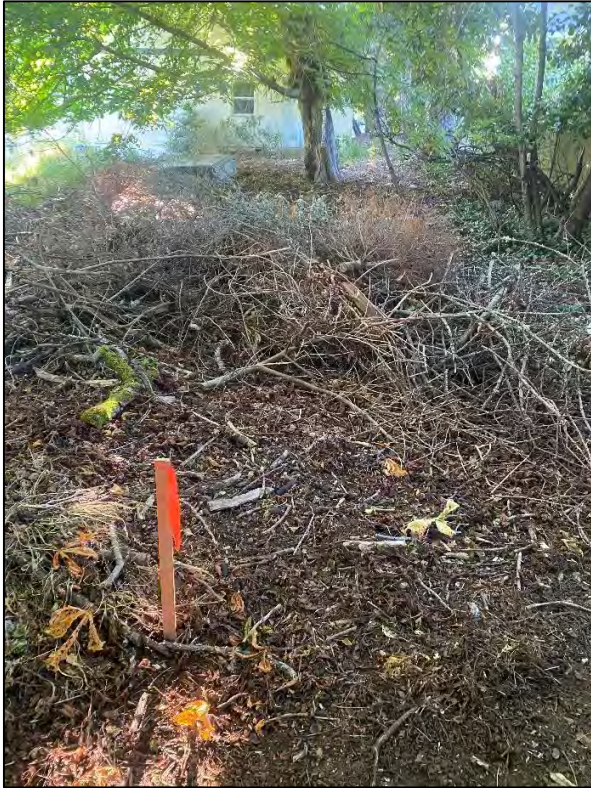
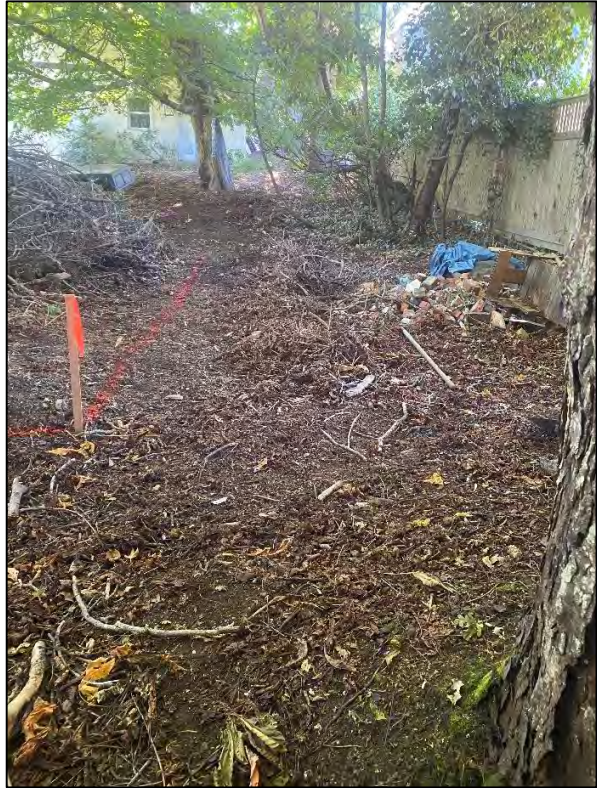
Photographs 2-5: Prior to breaking ground, the proposed corners of "Building C" were identified by a survey team using wooden stakes with orange marking ribbon. We then removed existing debris near the subject trees and delineated the lines of our exploratory excavations with orange marking paint.

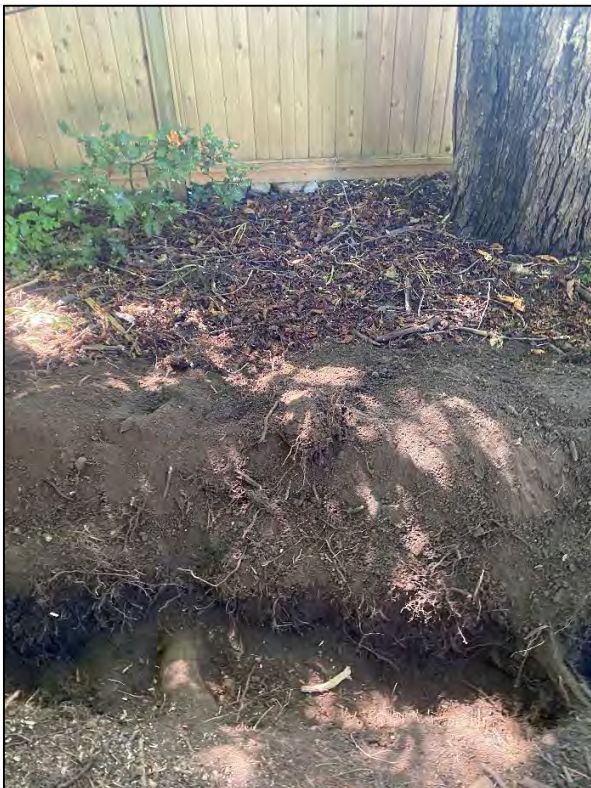
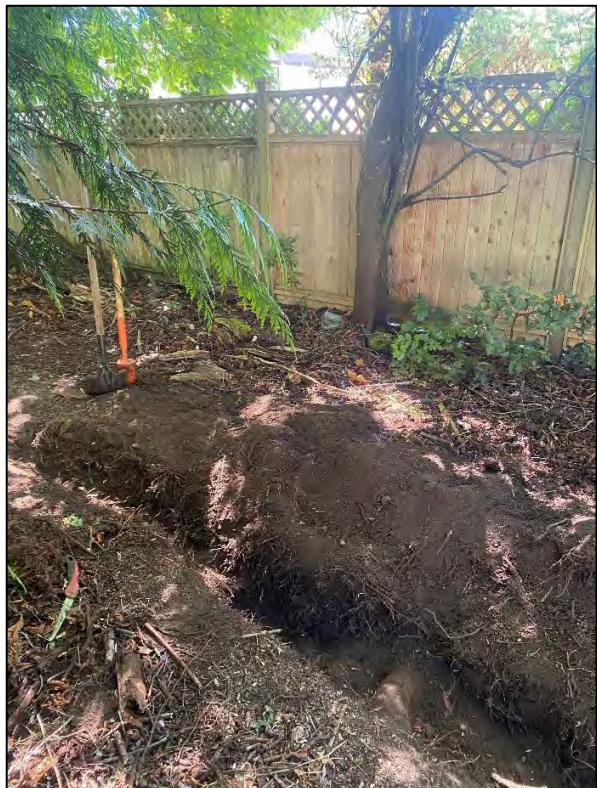
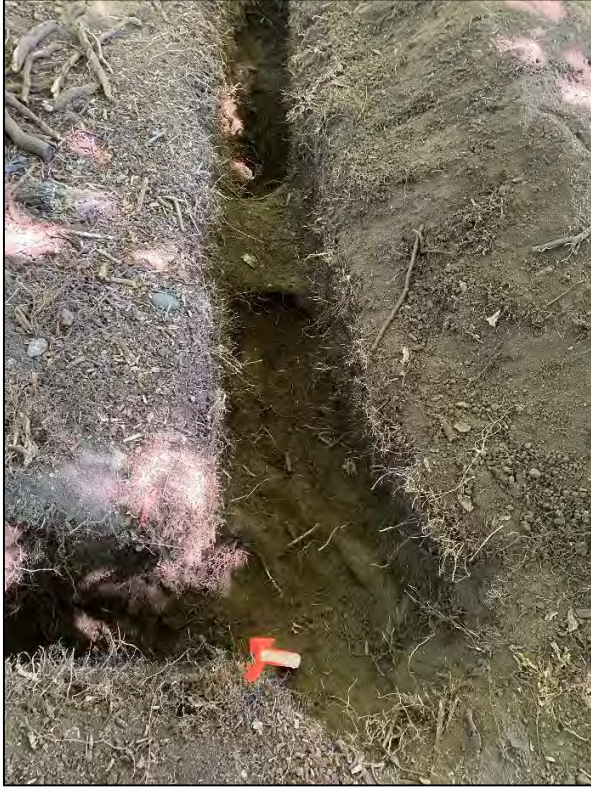
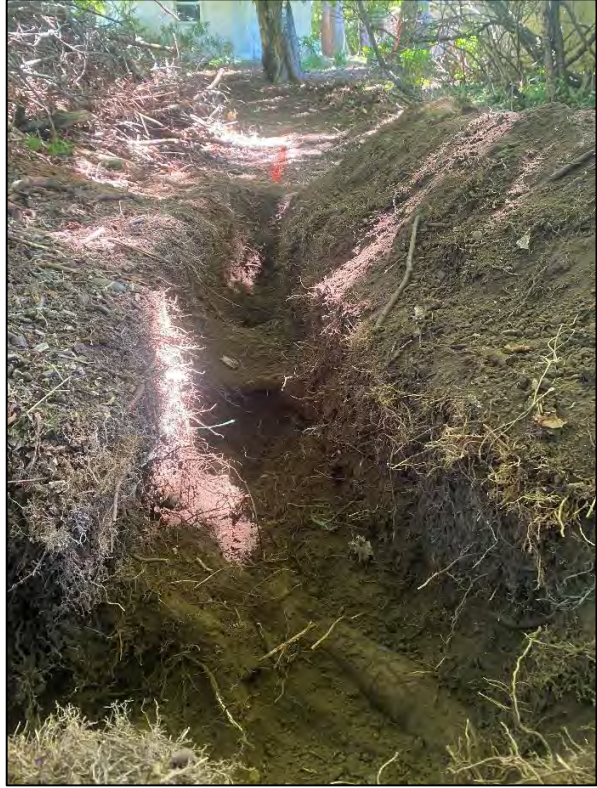
Photographs 10-13: Exploratory excavation within the CRZs of #989 & 990 encountered a cluster of medium-sized roots (~5-9cm Ø) at ~0.5m north of the proposed "Building C" corner (**above**) and a similar cluster at ~1m east of the corner (**below**). 1x ~8cm Ø and 1x ~6cm Ø were also encountered at the corner itself (**above**). An additional 1x ~6cm Ø root was encountered at ~1.5m north of the corner (**below**).

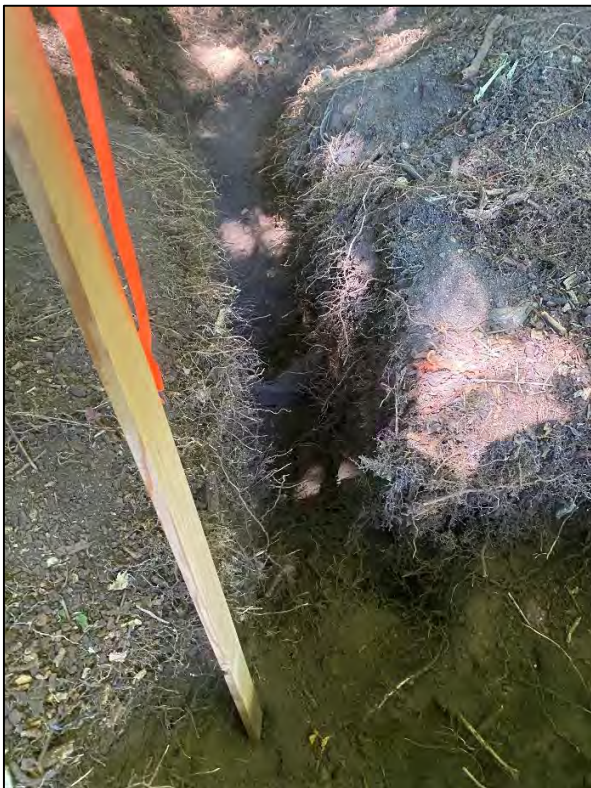
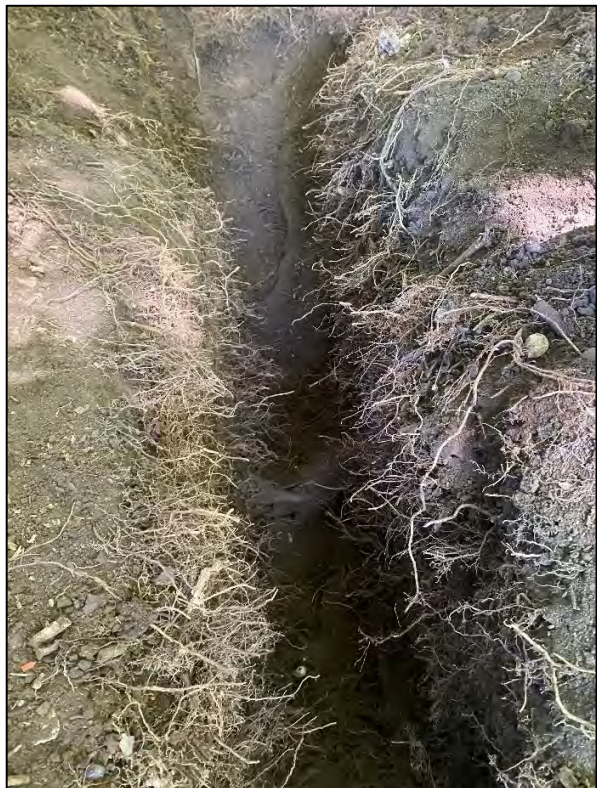
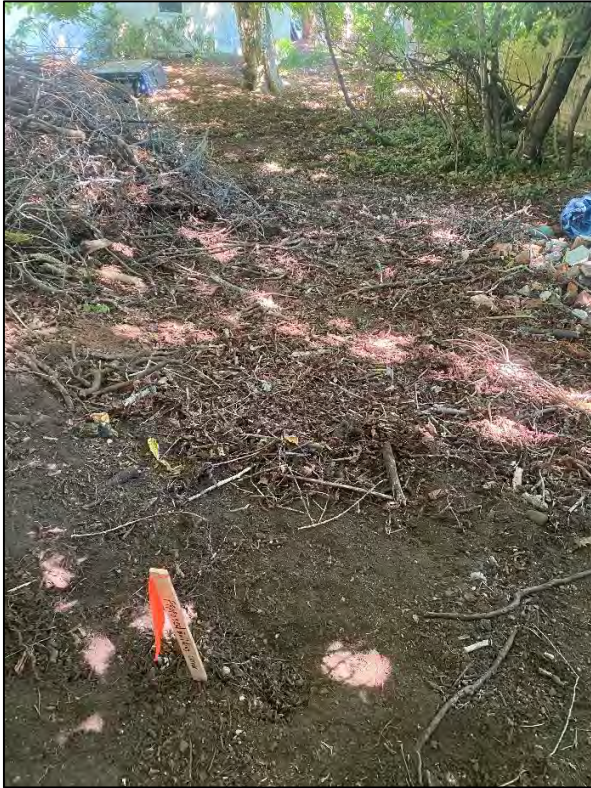
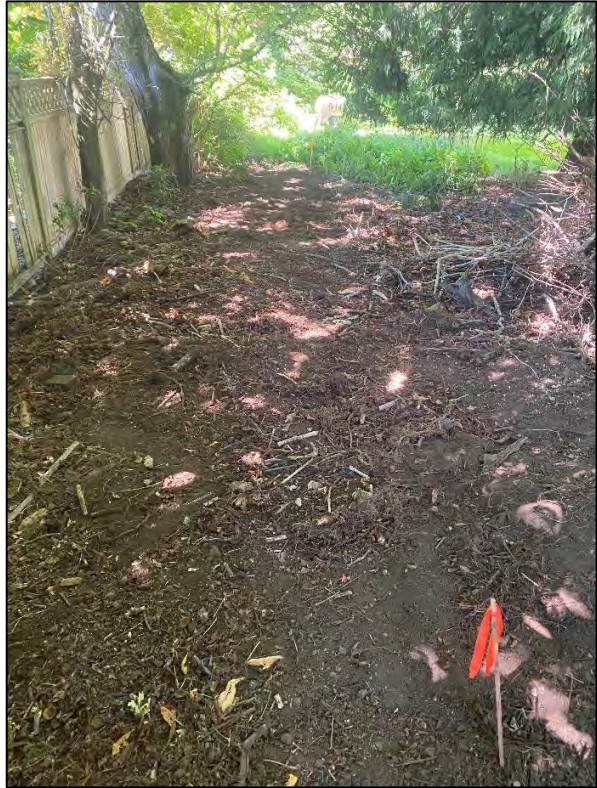
Photographs 14 & 15 (above): The hand-dug trenches were backfilled with on-site soil once exploratory excavations were complete.
Photographs 16 & 17 (below): #987 with decayed wound in lower trunk (**left**); #989 with inclusion and potential decay near the union (**right**).
