# HERITAGE CONSERVATION PLAN

LAWSON RESIDENCE  
960 FOUL BAY ROAD, OAK BAY, BC  
DECEMBER 2025

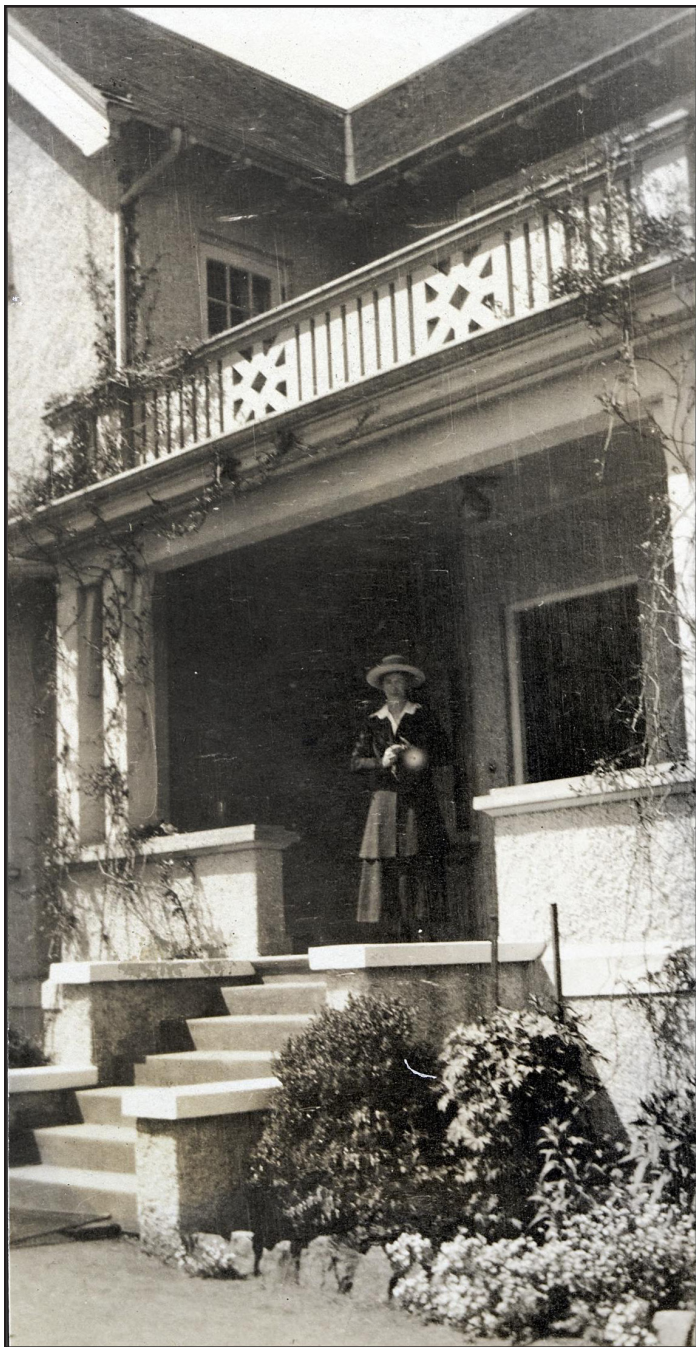
Fig. 10: Archival photograph showing the front entrance to 960 Foul Bay Road with a view of the porch above, prior to being closed in. (Source: Uno Langman Collection UBC Robert Sinclair Album, 1-0053546.0032)

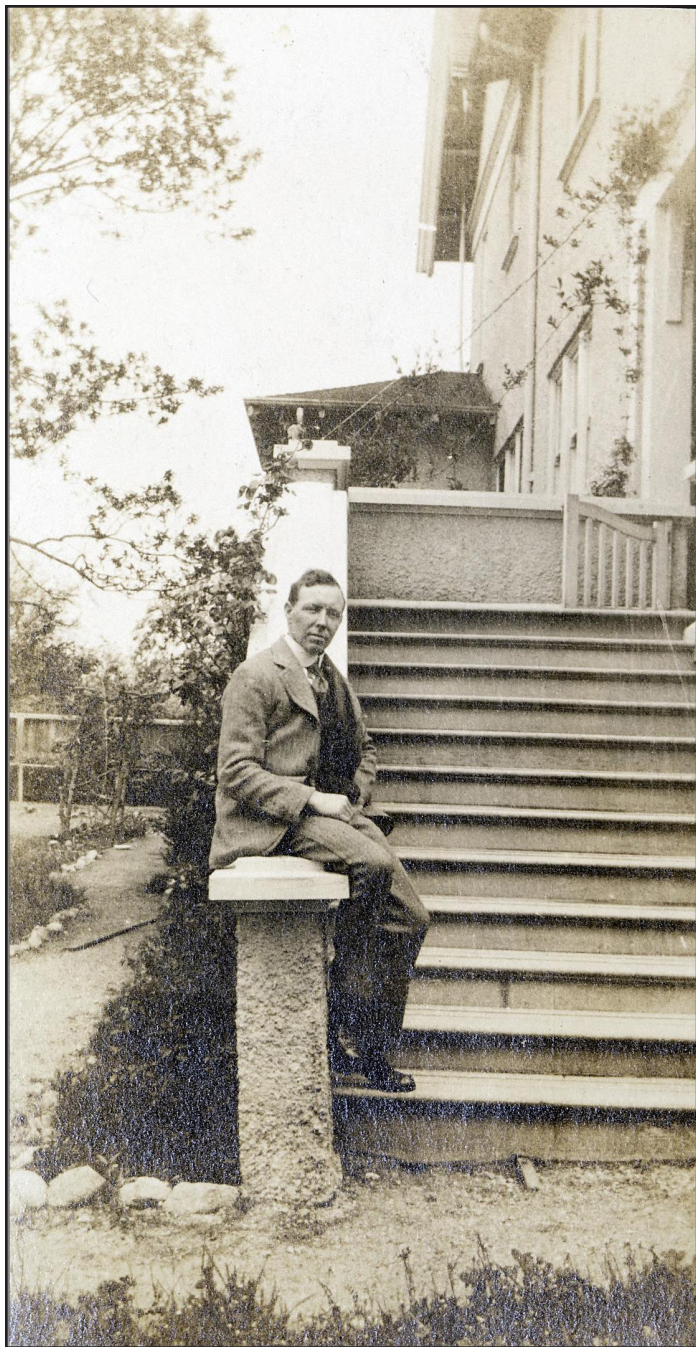
Fig. 11: Archival photograph showing the side staircase and back entrance to 960 Foul Bay Road. (Source: Uno Langman Collection UBC Robert Sinclair Album, 1-0053546.0010)

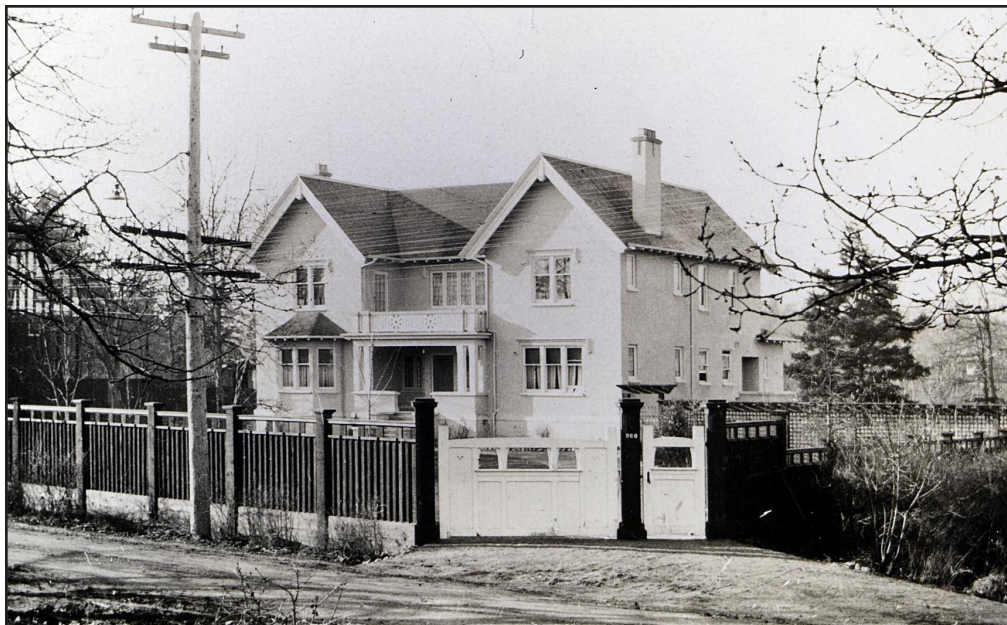
Fig. 13: Archival photograph showing the view of 960 Foul Bay Road from the street, also illustrating the former look of the property's fencing and the house's front facade, including its window decorative detailing. (Source: Uno Langman Collection UBC Robert Sinclair Album, 1-0053546.0194)

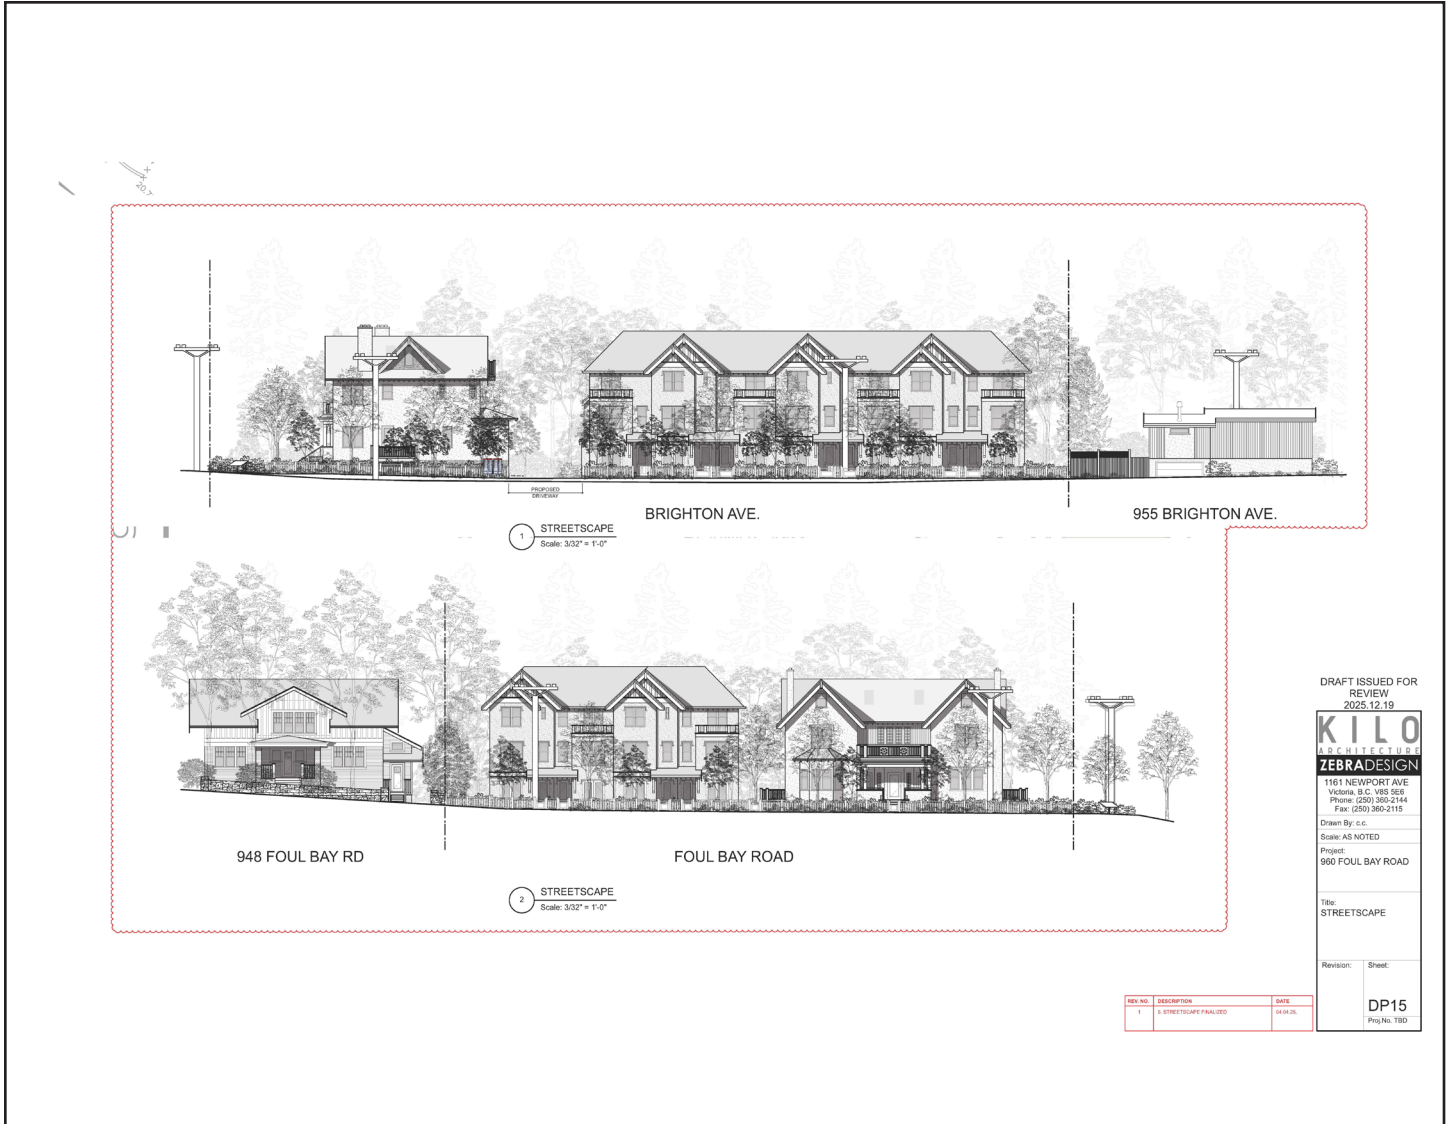
Fig. 20: Proposed revised streetscape. Above, shows the elevations along Brighton Ave, with the Lawson Residence on the left and the infill development on the right. Below, shows the elevations along Foul Bay Road, with the Lawson Residence on the right and another infill development on the left. (Source: Kilo Architecture and Zebra Design)

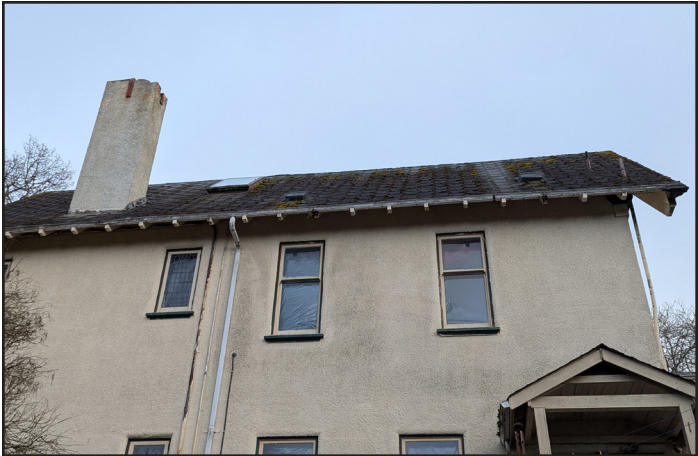
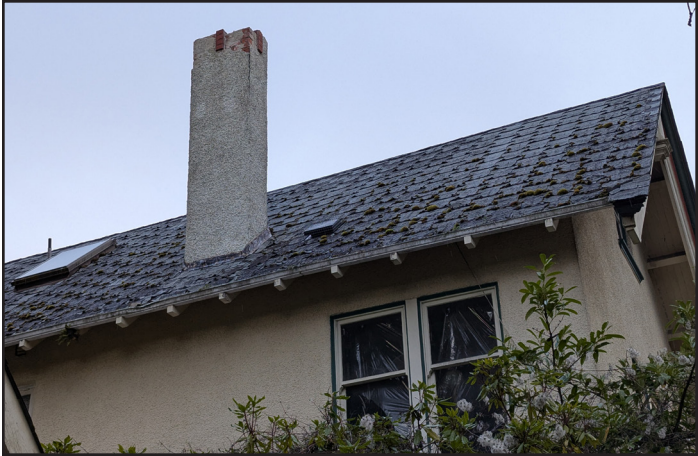
Figs. 23 and 24: Views of the northern side of the roof (above) and the southern side of the roof (below), 2025. (Sources: Cummer)

It is unclear how old the current roof is, however, its condition is poor, overall, with curling and decaying shingles as well as moss growth in places (Figs. 23 and 24). Roof replacement is highly encouraged. It is difficult to determine the full condition of the drainage system from a simple exterior inspection. As part of this conservation work though, the drainage system (including the elements below ground) should be upgraded to guarantee optimal performance, with a regular maintenance schedule put in place to ensure their continued efficient and effective functioning.

**Roofing and Drainage Conservation Strategy**  
 Preservation, Restoration and Rehabilitation

- The original roof elements (the bargeboards, fascia boards, soffits and decorative drop finials) will be **preserved**, where possible, and **restored (replaced in-kind)**, if needed.
- The roofing and drainage will be **rehabilitated** with a new roof and drainage system being installed. These should be regularly monitored and maintained to ensure their ongoing good condition.

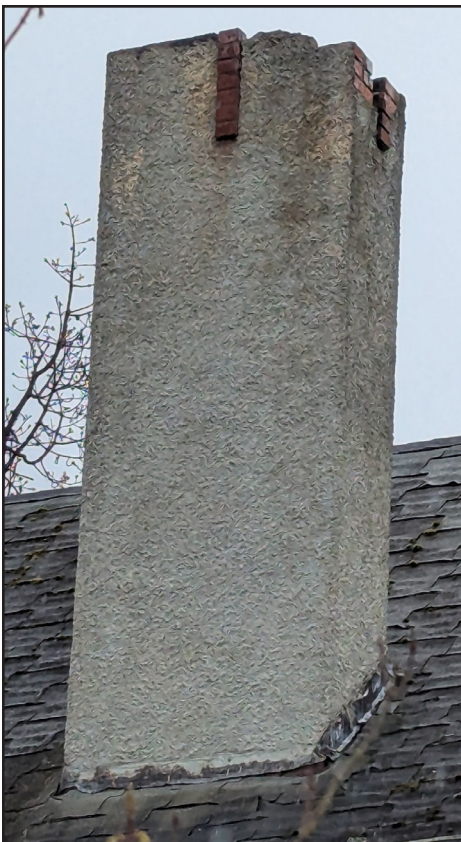
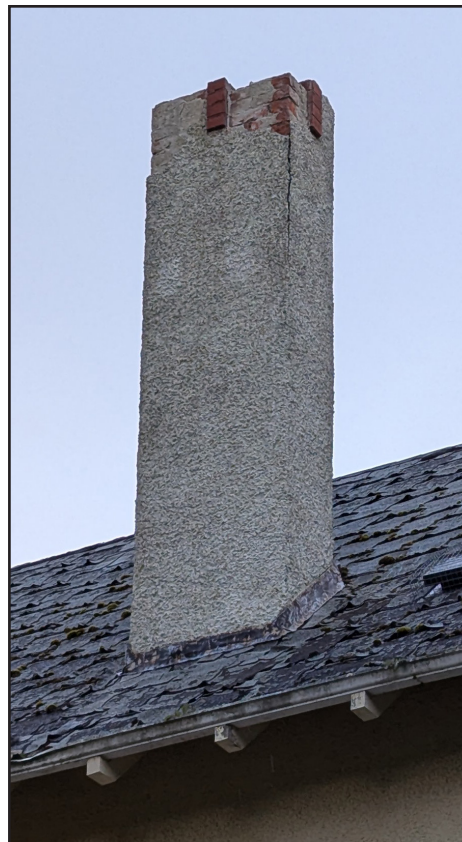
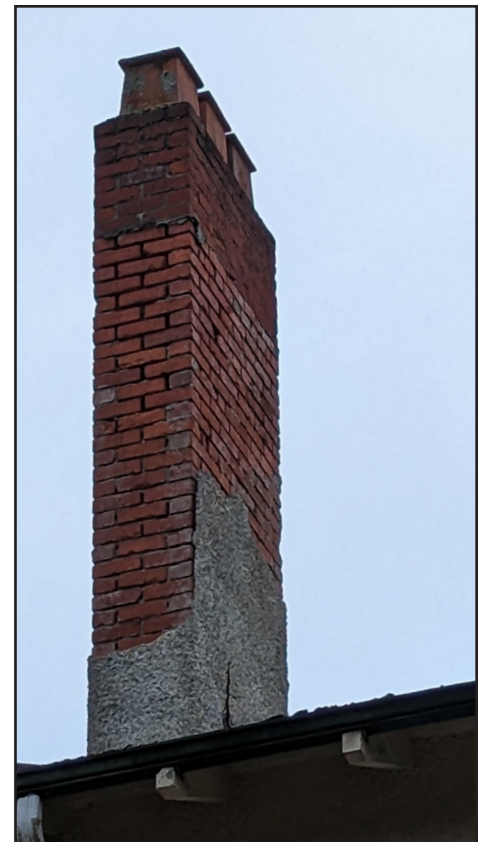
There are three chimneys on the house, all in largely poor condition. Two of the three (the northern and southern side chimneys) have had their top bricks and chimney caps fall off, but with their stucco intact (Figs. 25 and 26). However, the western, rear chimney still has its chimney caps, but has lost most of its stucco with other signs of deterioration including loss of mortar (Fig. 27). The chimneys will need to be documented, prior to relocation, to ensure they can be properly restored in their new location.

- Two of the three chimney forms (Figs. 25 and 26) will be **preserved** and **restored** following relocation.
- The chimney at the rear of the roof, in the poorest condition (Fig. 27), will be removed to facilitate an altered rear roof configuration to improve livability.
- Each chimney should be investigated prior to relocation to determine their structural integrity.
- If dismantled prior to relocation, the chimneys should be thoroughly documented beforehand, so that their original appearance can be replicated and restored.
- The caps and bricks from the removed chimney should be inspected and those in good condition should be kept and used for any repairs needed on the surviving two.

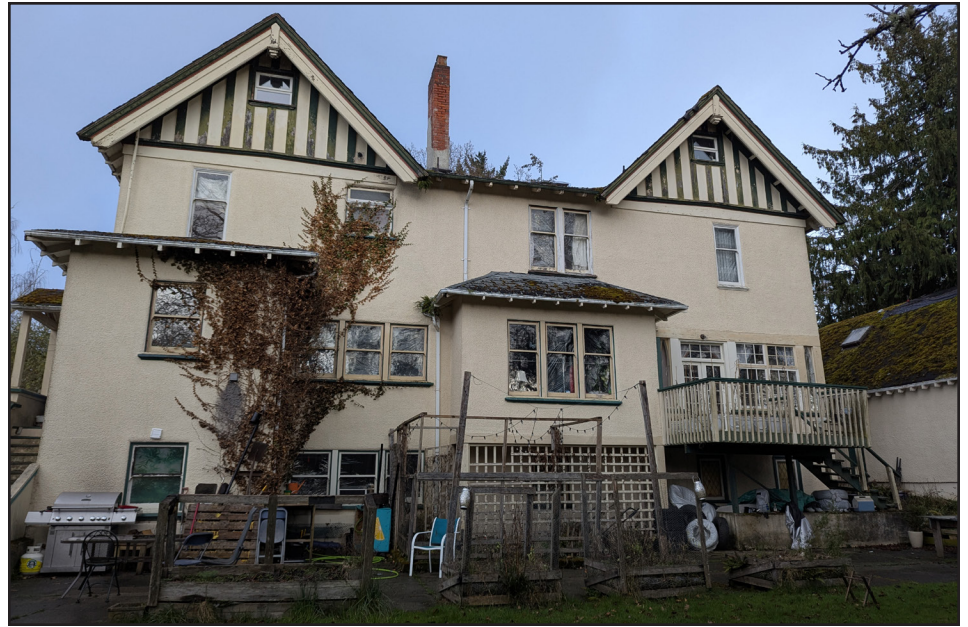
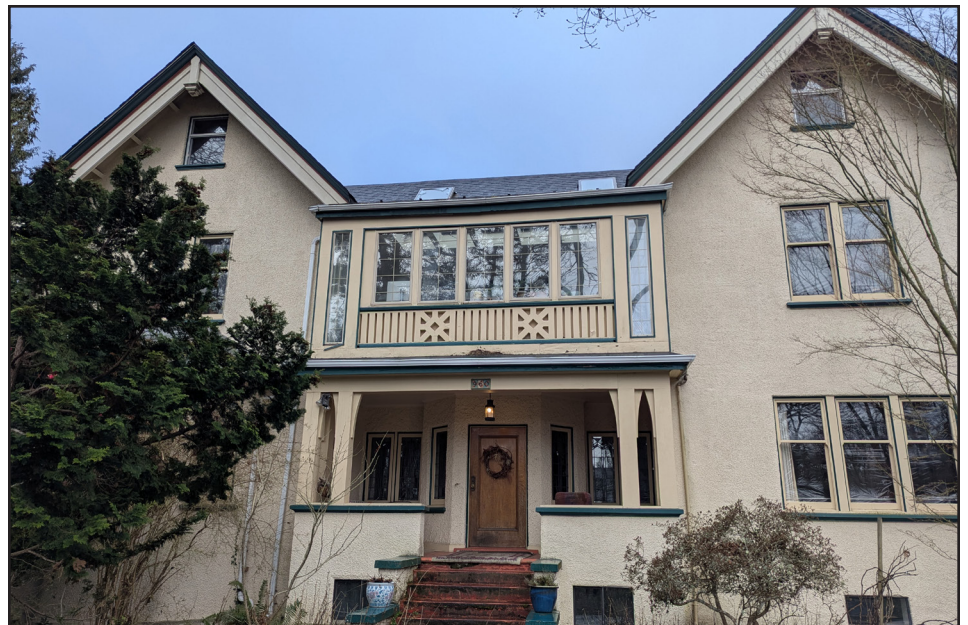
Figs. 28 and 29: Views of the rear façade (above) and the front facade (below), showing the numerous original horned wood windows with insulation film on the interiors as well as the newer windows added in the four gables (front and back), 2025. (Sources: Cummer)

Most of the windows on 960 Foul Bay Road are original and are in fair to good condition. That being said, internal performance appears to be a concern, as discernible from the insulation film put on most of the windows (Figs. 28 and 29). As shown in comparing the original drawings to the current façades, there are also four windows that are not original, which were installed in the four gables of the residence at some point in time (Figs. 28 and 29). The original front door appears to be in good, operable condition (Fig. 29).

The exterior stucco appears to be in fair to good condition (Figs. 28 and 29 above), with areas simply in need of cleaning, which will be addressed when the house is repainted. As is the case with the half timbering in the rear gables as well (Fig. 28 above).

The landscaping on site is quite overgrown, but is, for the most part, sufficiently at a distance from the historic structure. However, it is more abundant in the southeast corner (Fig. 29) and there are also vines growing on the building at the rear (Fig. 28 above). This should be removed and discouraged as it can damage the building. After relocation, any new landscaping should be planted at a sufficient distance to avoid damaging the structure and its finishes.

- There is a wide range of interventions being employed with regards to the windows (Figs. 30 and 31). Where possible, remaining original wood windows should be **preserved**. If any sashes, sills and/or trims need repair or replacement, these should be **replaced, in-kind**.
- Each window should be made weather tight by re-puttying and weather-stripping, as necessary.
- Retain and **preserve** the door openings in their original locations and **preserve** the original doors, where possible. **Restore** them with new staining.

- The stucco cladding should be **preserved** and **restored**, with extensive cleaning carried out on all sides, using gentlest means possible; do not use power-washing or harsh chemical cleaners as this can damage the building.
- The house should be repainted in its entirety. As outlined in the 2018 HCP, “the stucco was originally unpainted, and therefore a mortar grey colour. The only other original applied colour was an ivory colour on all painted surfaces” (DLA 2018, p. 27) (colours illustrated to the left).
- The current colour scheme does not need to be maintained, but an appropriate historic colour scheme should be chosen.
