960 FOUL BAY ROAD—OAK BAY, BC

CONSTRUCTION IMPACT ASSESSMENT & TREE MANAGEMENT PLAN

DATE OF ISSUANCE: December 29th, 2025

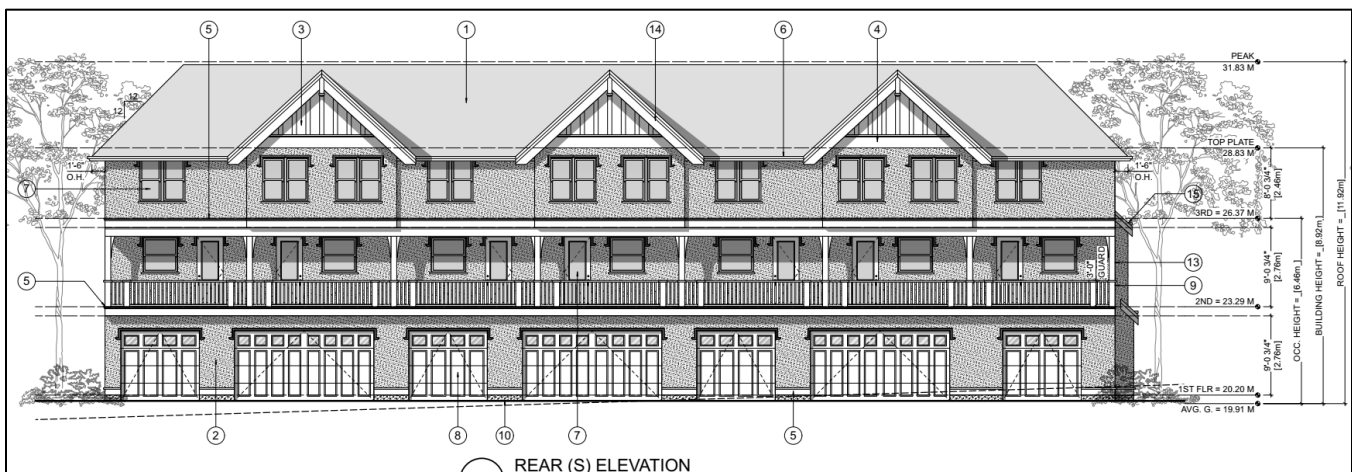
- Given the relatively strong wound compartmentalization exhibited by the species, it is our opinion that the proposed clearance pruning is unlikely to result in significant impacts to the long-term health or structural condition the tree, provided large limbs are maintained above ~9m AGL. Based on the proposed 1:1 slope of the roof line, retained limbs above 9m AGL should maintain at least 1m clearance from finished eaves and roofing. The project arborist should be contacted to meet with the pruning contractor prior to commencement of work. All pruning shall be completed by an ISA Certified Arborist.

Figure 5: Snapshot from the preliminary building plans July 31st, 2025) showing the proposed "Building C" elevations. **Not to scale.**

- If scaffolding is necessary and triggers additional pruning of large limbs, the project arborist should be consulted. Depending on the extent of pruning required, we may recommend alternatives to full scaffolding such as hydraulic lifts, ladders or platforms. Methods to avoid soil compaction may also be specified.

- Depending on the sequence of permit issuance, we may also advise pruning be completed in phases. In this scenario, it is likely most practical to perform canopy clearance pruning as early as possible prior to the outset of building construction—this may maximize the tree’s adaptation interval prior to root pruning.

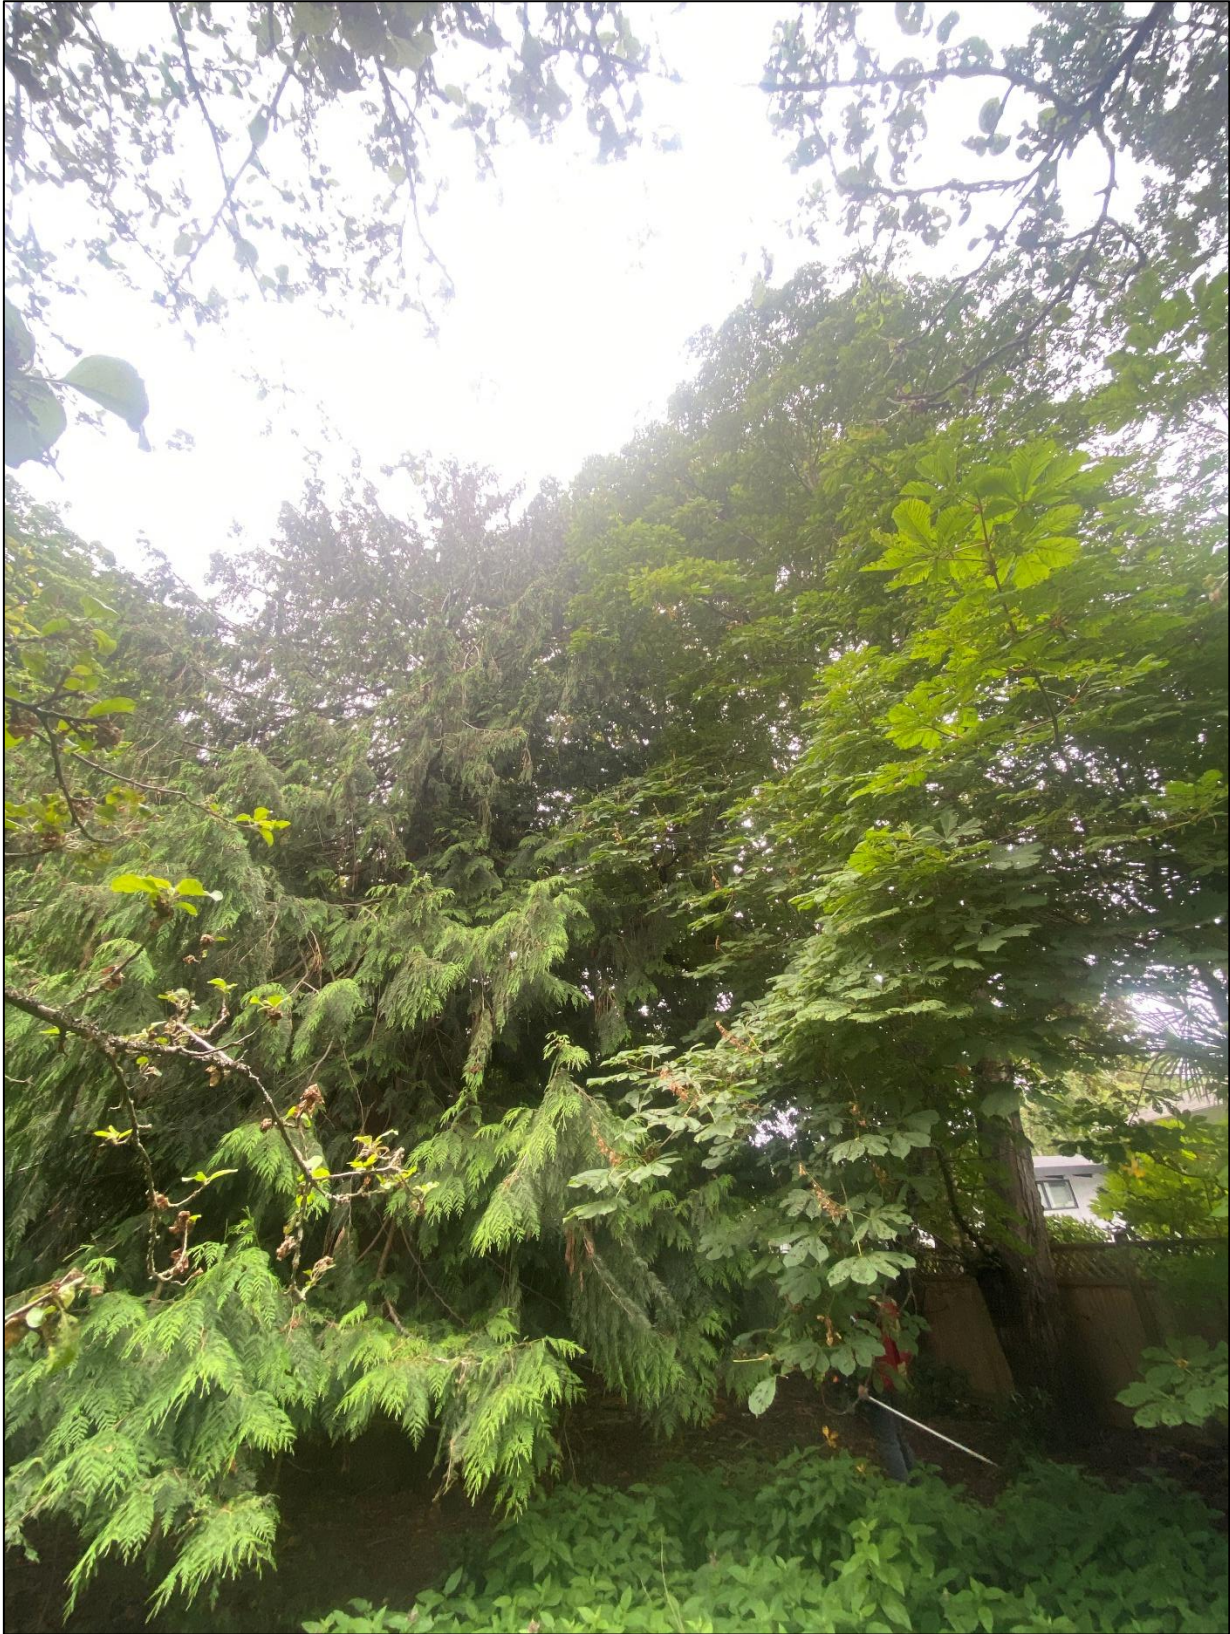
- At the time of our site visit, the trees appeared to be in fair-good health (**see photograph 1**).
- We observed a large wound in the lower trunk of #987 (with associated decay), likely arising from the failure of a secondary stem or scaffold limb (historically)—**see photograph 16**. Crown raising (historically) was also noted, with surface decay visible in the wounds. The tree also leans slightly west.

Photograph 1: *The trees were in fair-good health on the date of our site visit.*
