960 FOUL BAY ROAD—OAK BAY, BC

CONSTRUCTION IMPACT ASSESSMENT & TREE MANAGEMENT PLAN

DATE OF ISSUANCE: January 2, 2025

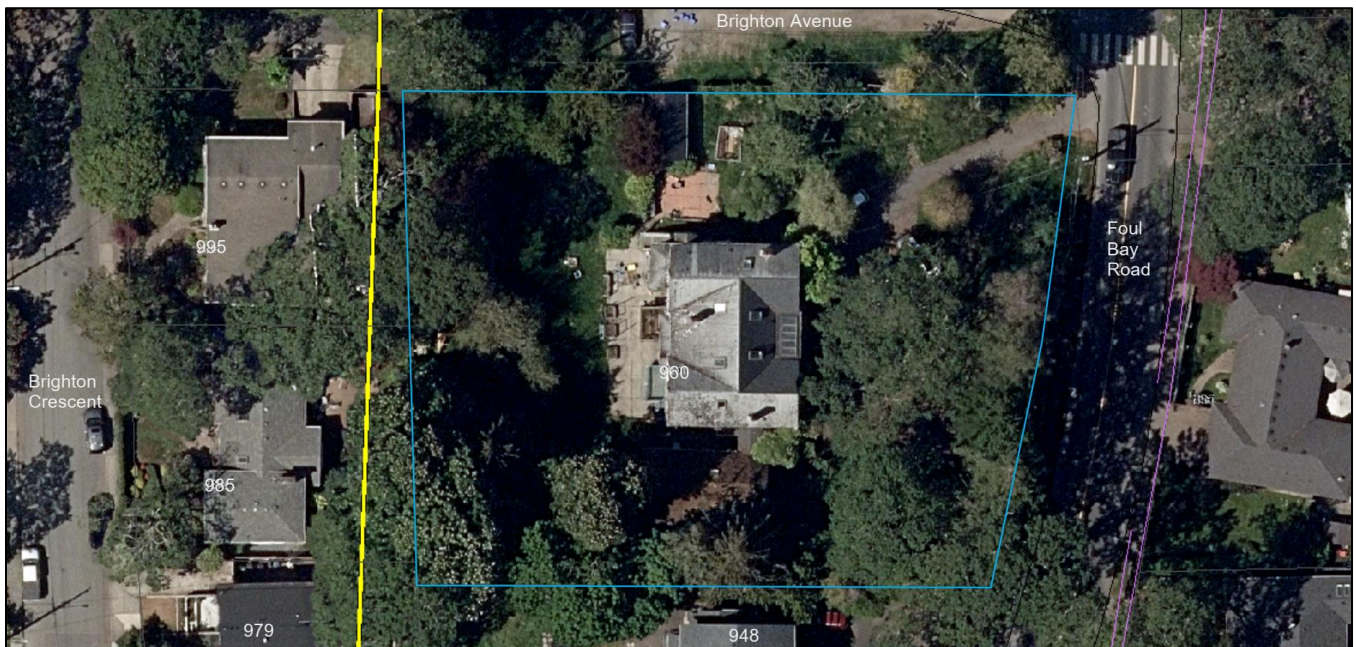
Figure 1: Site context air photo: The approximate boundary of the subject site is outlined in blue.

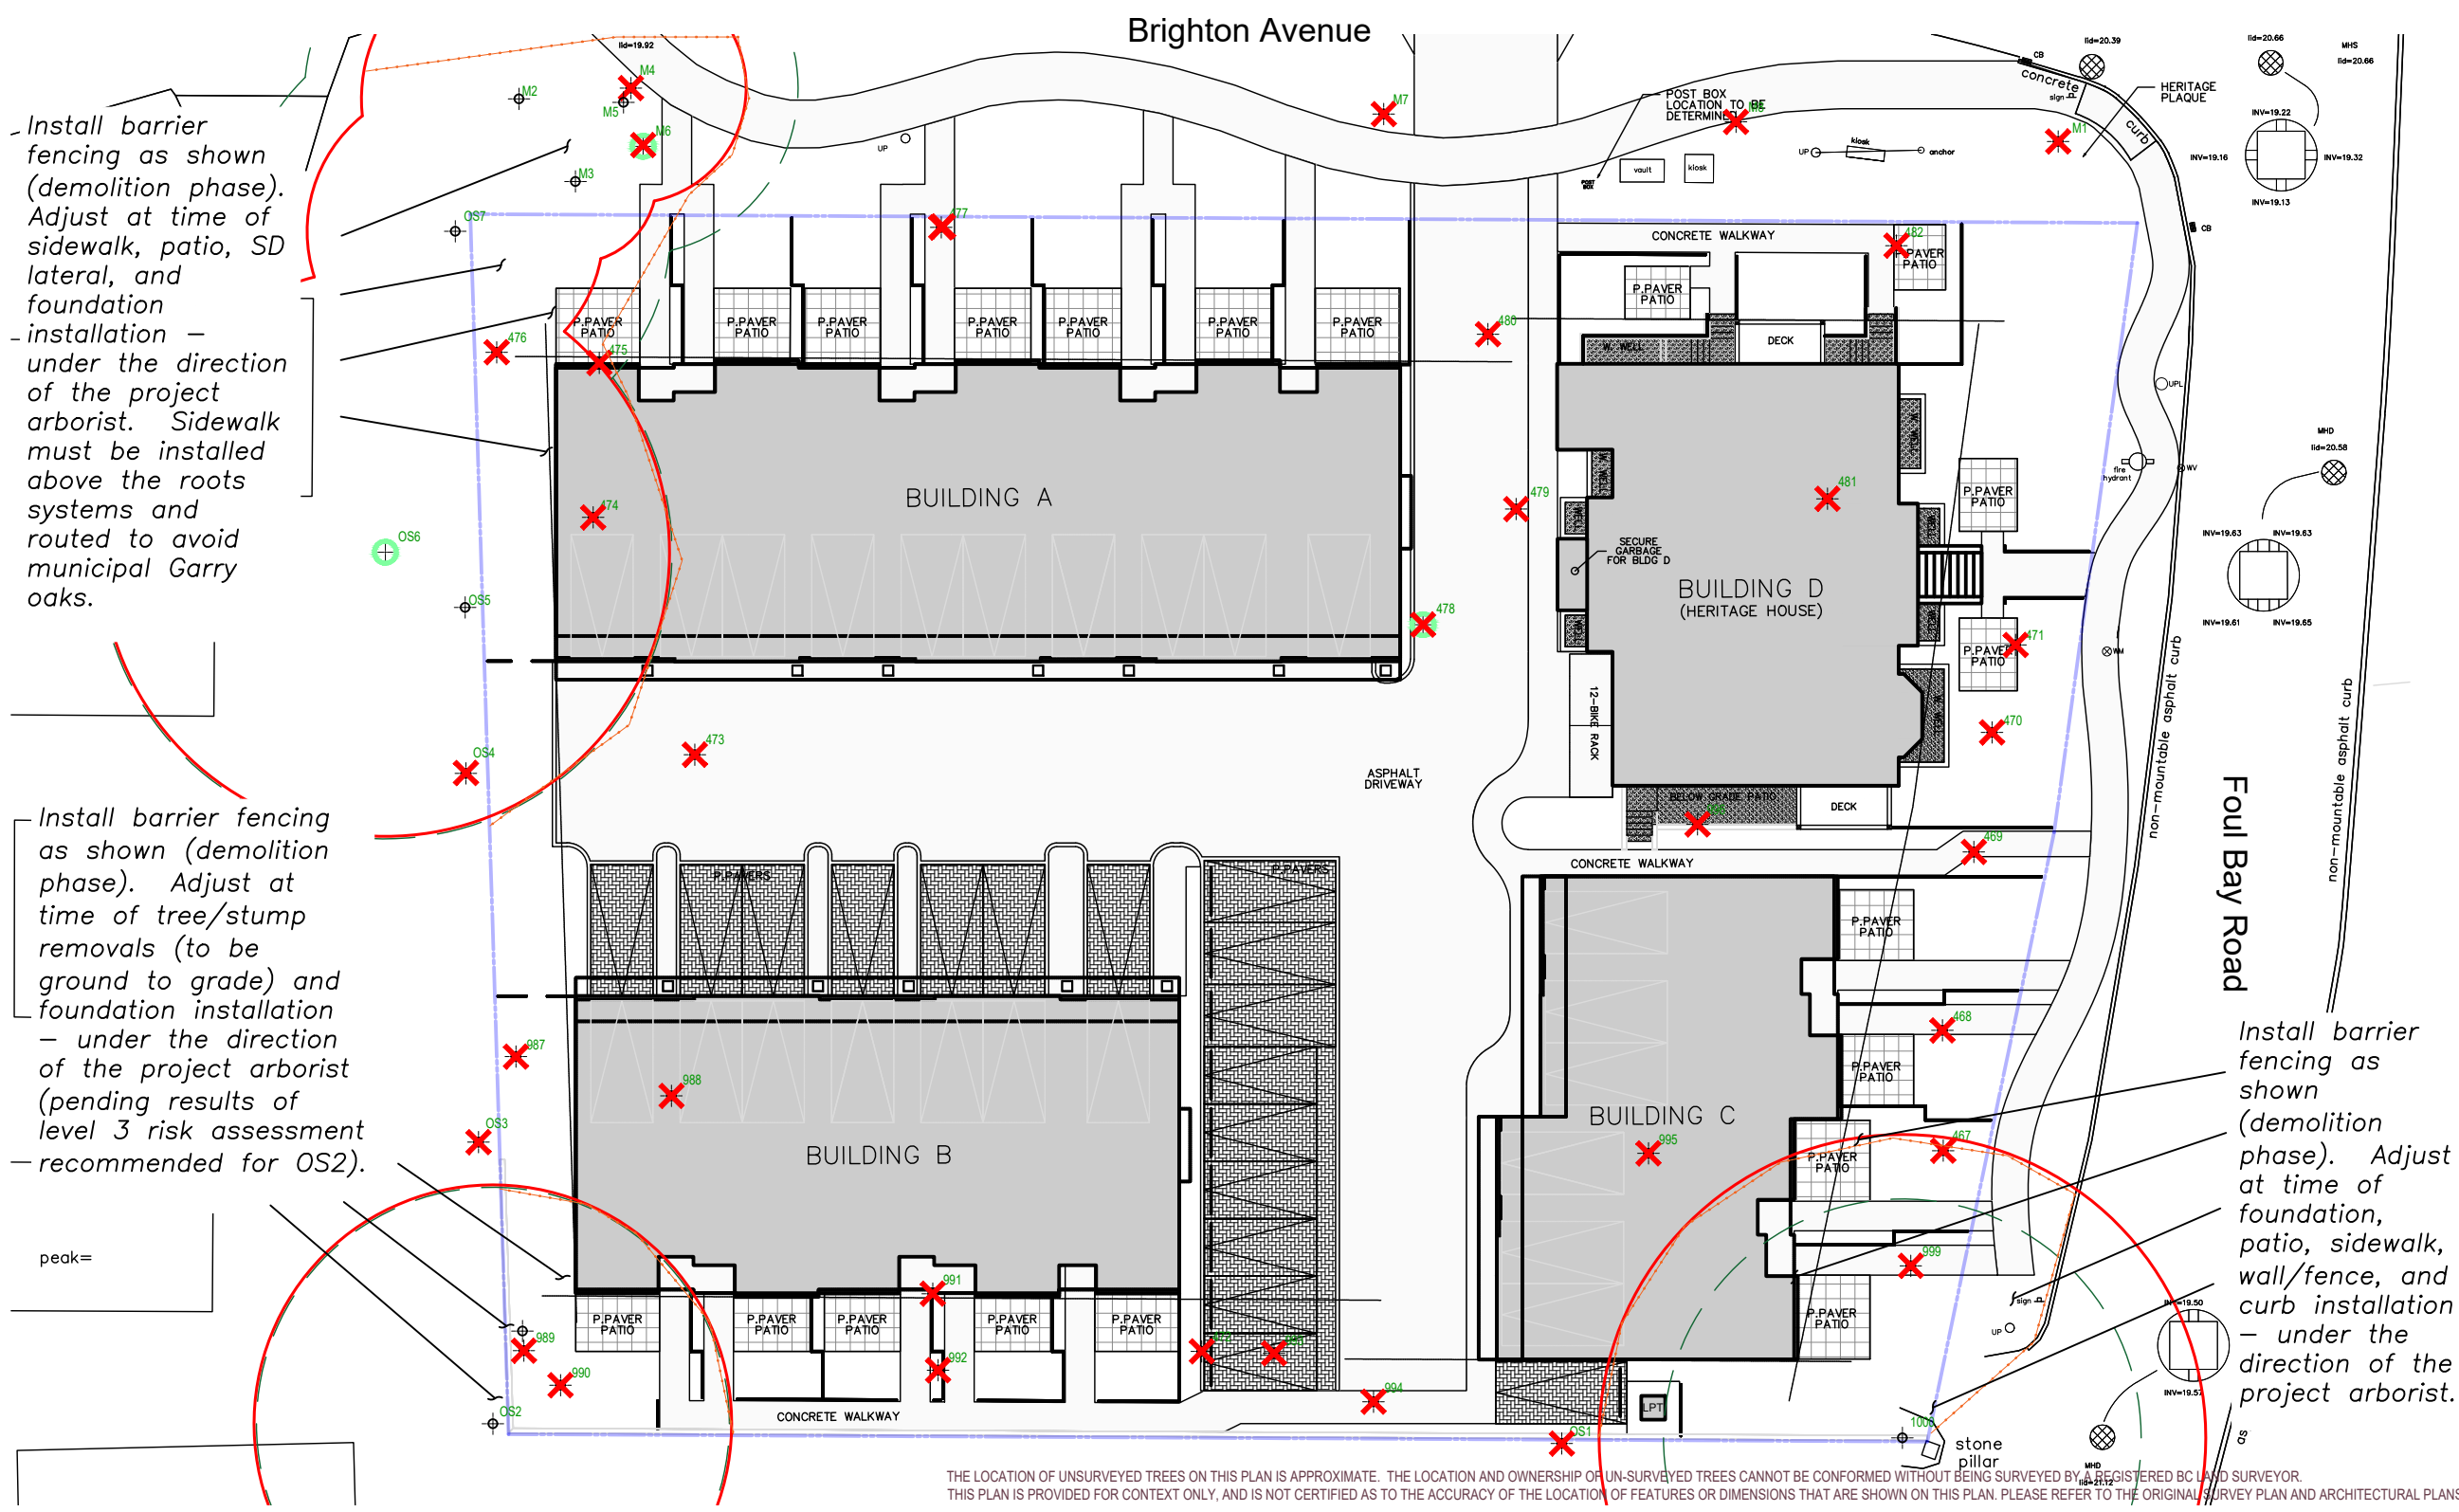
APPENDIX A – TREE MANAGEMENT PLAN

The following municipal trees are located where they are likely to be severely impacted by proposed construction and are recommended for removal:

The following bylaw-protected on-site trees are located where they are likely to be severely impacted by proposed construction and are recommended for removal:

The following bylaw-protected off-site trees are located where they are likely to be severely impacted by proposed construction and are recommended for removal:

All excavations related to storm drain (SD) lateral and associated manhole (MH) within the CRZs of **Garry oaks** (*Quercus garryana*) **M2, M3, and M5** (66cm, 34cm, and 40cm DBHs, respectively) must be supervised by the project arborist. We further recommend the following:

- All excavations within the CRZs shall be completed using low-impact techniques—we recommend hydro-vac operated according to project arborist instructions.
- All roots critical to the trees' survival and/or stability must be preserved. If critical roots are encountered and require pruning, the trees may have to be removed.
- We also anticipate non-protected on-site trees will require clearance to accommodate the proposed SD lateral/manhole. Care must be taken to avoid damaging municipal trees proposed for retention during this process. We recommend arborist supervision during removal of stumps and portions of canopy where these overlap with the CRZs and drip lines of trees proposed for retention.

- We anticipate non-protected on-site trees and municipal tree M6 will require clearance to accommodate the proposed sidewalk. Care must be taken to avoid damaging municipal trees proposed for retention during this process. We recommend arborist supervision during removal of stumps and portions of canopy where these overlap with the CRZs and drip lines of trees proposed for retention.
