960 FOUL BAY ROAD—OAK BAY, BC
CONSTRUCTION IMPACT ASSESSMENT &
TREE MANAGEMENT PLAN

PREPARED FOR: 960 Foul Bay Holdings c/o Jennifer Travelbea
754 Humboldt Street
Victoria, BC
V8W 4A1

PREPARED BY: Talmack Urban Forestry Consultants Ltd.
Robert McRae – Consulting Arborist
ISA Certified # PN-7125A
Tree Risk Assessment Qualified
Tree Appraisal Qualified

DATE OF ISSUANCE: December 29th, 2025

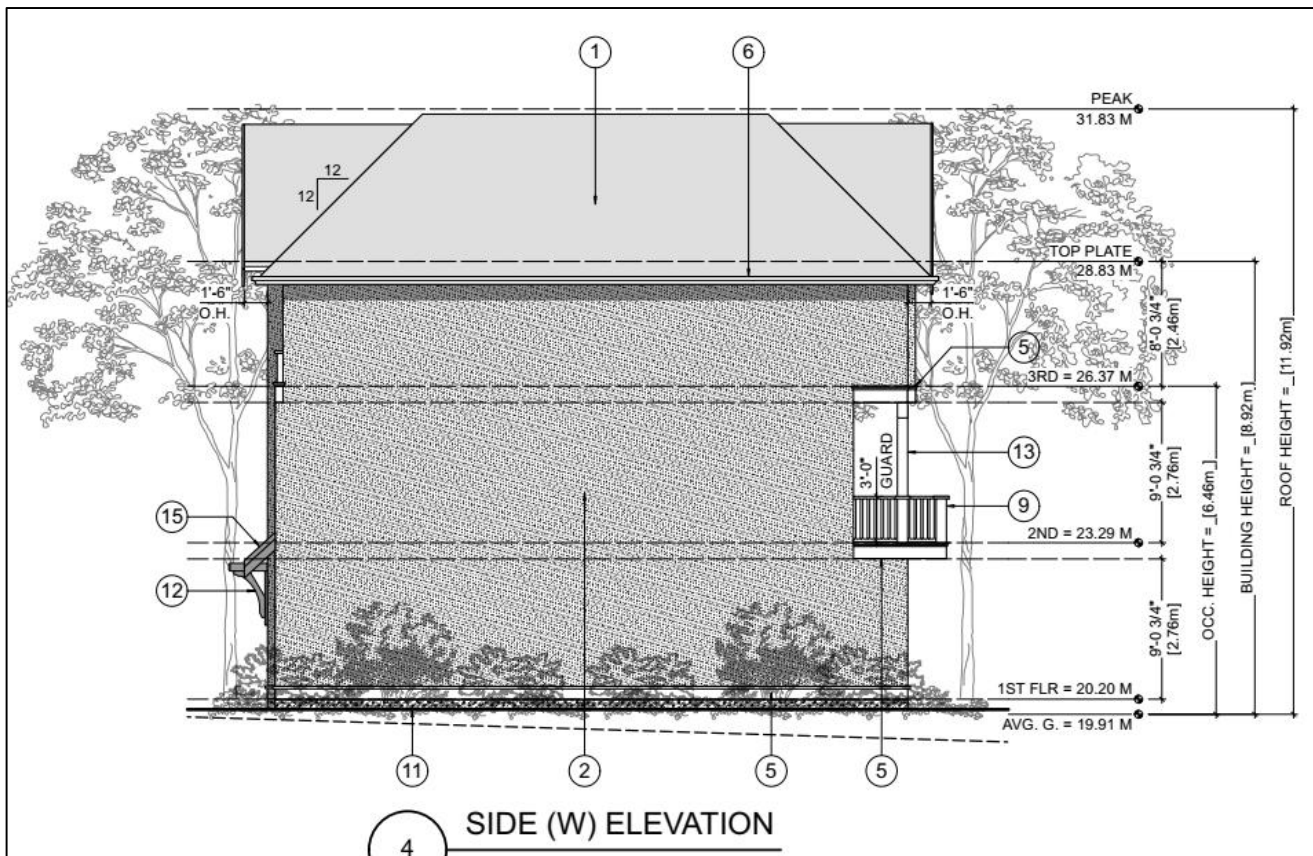
Figure 3: Snapshot from the preliminary building plans July 31st, 2025) showing the proposed “Building C” elevations. **Not to scale.**

- Based on the 11.92m building height specified on the plans and the proximity to the trees, we estimate that the most substantial clearance pruning will be required within the canopies of #989 & 990.
 - #989 will likely require pruning of 2x ~15cm Ø and 2x ~10cm Ø limbs at the branch collars up to ~9m above level (AGL), with larger branches above potentially in need of reduction or removal. **See photograph 18.**
 - #990 will likely require pruning of 2x ~12-15cm Ø and 1x ~10cm Ø limbs at the branch collars up to ~9m AGL, with larger branches above potentially in need of reduction or removal. **See photograph 19.**

- Given the relatively strong wound compartmentalization exhibited by the species, it is our opinion that the proposed clearance pruning is unlikely to result in significant impacts to the long-term health or structural condition the tree, provided large limbs are maintained above ~9m AGL. Based on the proposed 1:1 slope of the roof line, retained limbs above 9m AGL should maintain at least 1m clearance from finished eaves and roofing. The project arborist should be contacted to meet with the pruning contractor prior to commencement of work. All pruning shall be completed by an ISA Certified Arborist.

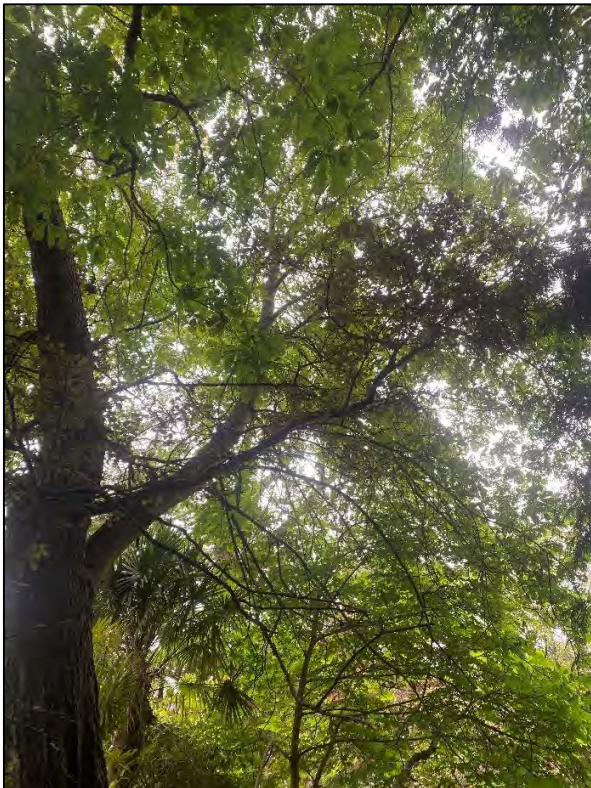
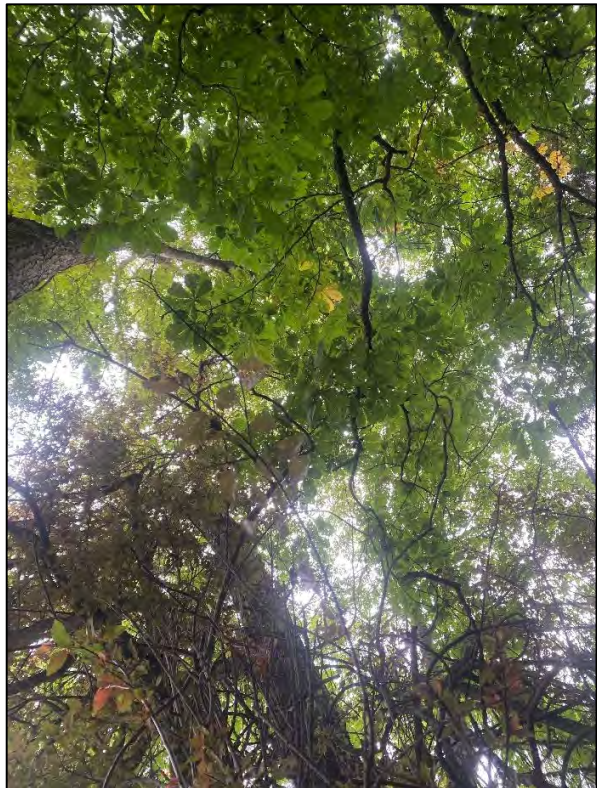
Photographs 18-21: Canopies of #987 (lower left), 989 (upper left), 990 (upper right), and OS3 (lower right) that require clearance pruning for the construction of the proposed "Building C."
